Jefferson High School Building Condition Report

312 S Main Street, Boulder, Montana 59632

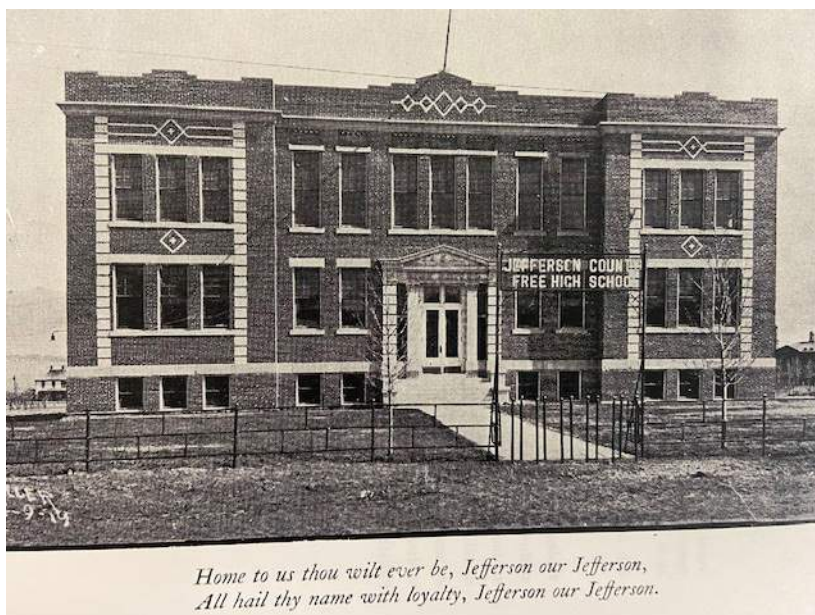
(image courtesy Jefferson High School)

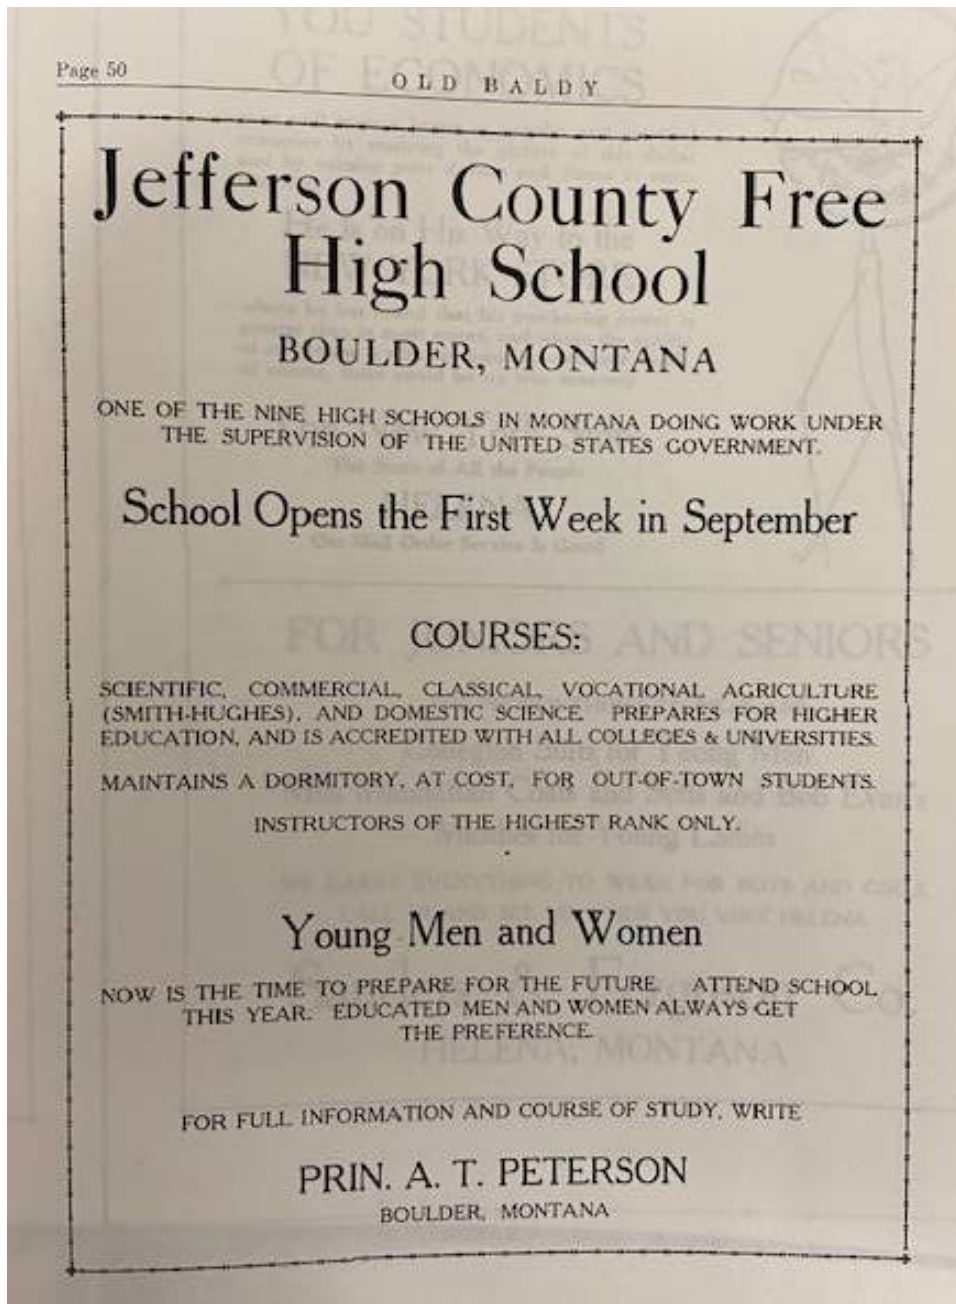
Local newspaper advertisement, circa 1921. (Courtesy Jefferson High School)

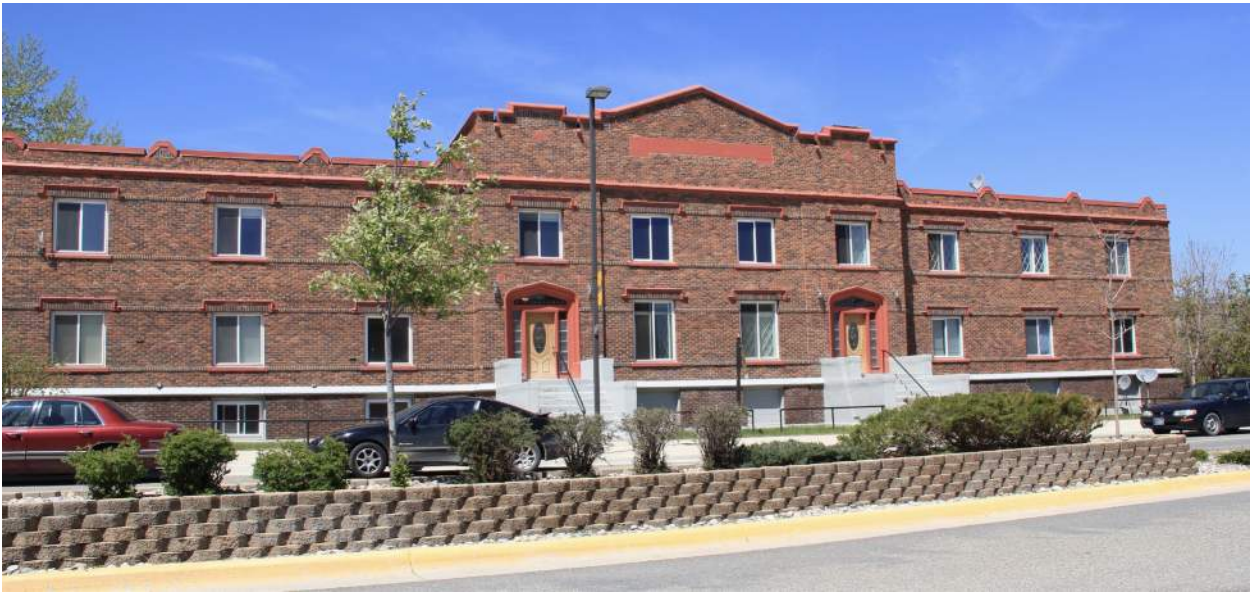
Directly across the street from the school is the original Jefferson High School dormitory, for students who would travel to Boulder and spend the week in town going to school, then return to remote ranches and communities. This building is converted into apartments. (Image courtesy of "Montana's Historical Landscapes"; <https://montanahistoriclandscape.com/2016/03/10/jeffersons-jewels/>, retrieved June 23, 2020)

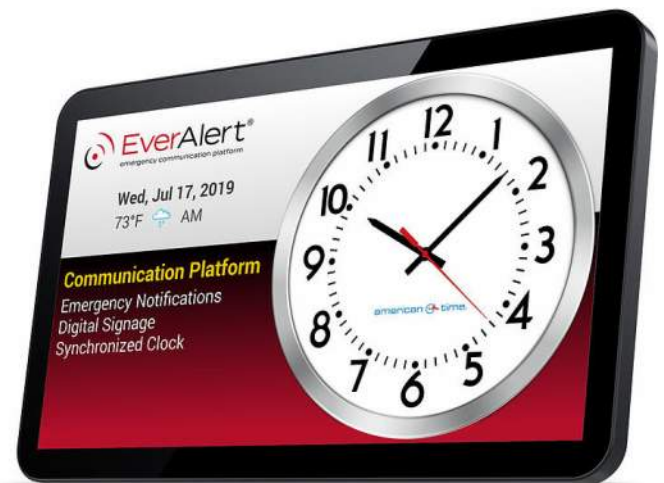
Modern clock/bell systems are remotely synchronized and can include messaging, emergency notifications, and extras such as weather and news.

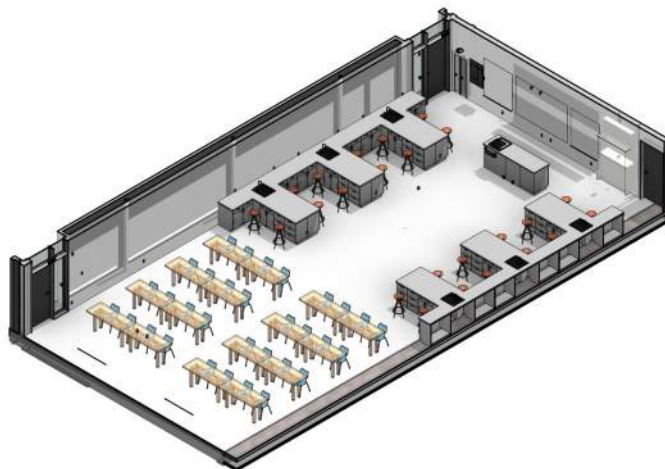
A typical science classroom in newer schools.

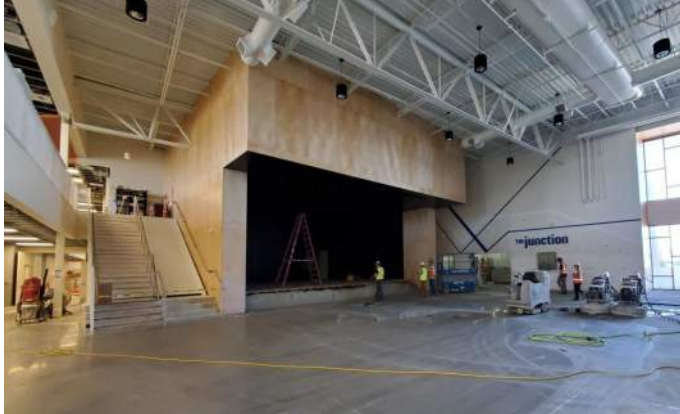
The central commons space at the new East Helena High School includes a performance area. Reverse-fold bleachers will close off the stage area when not in use.

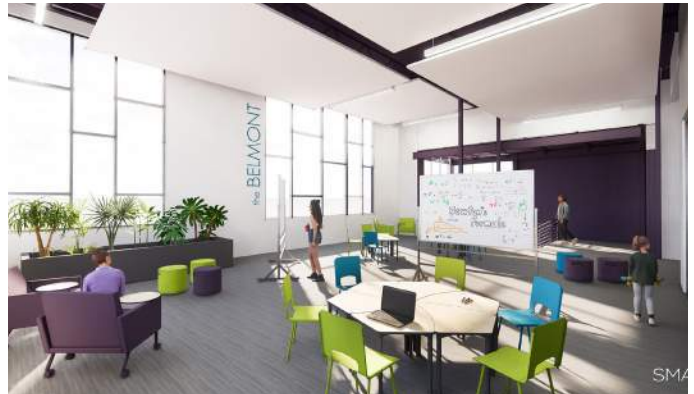
21st Century Learning Environments promote bright, flexible spaces that allow for varied use and teaching experiences.

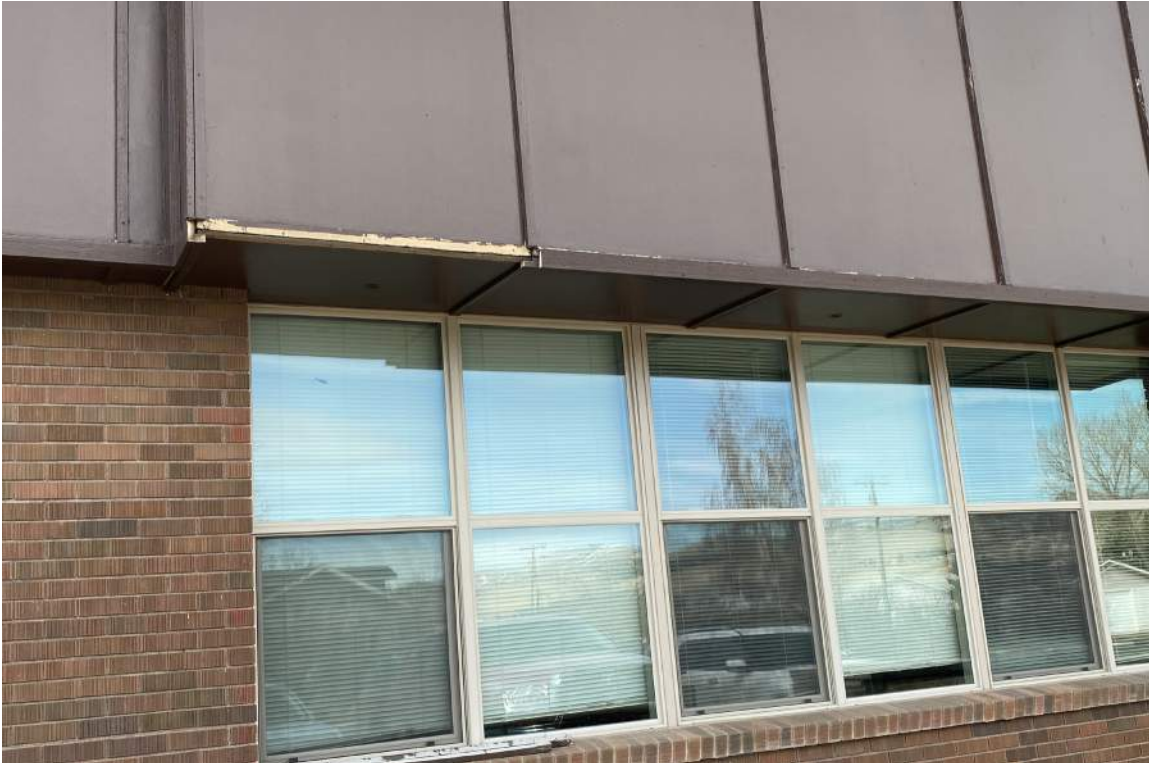
Wood fascia that is worn and coming apart.

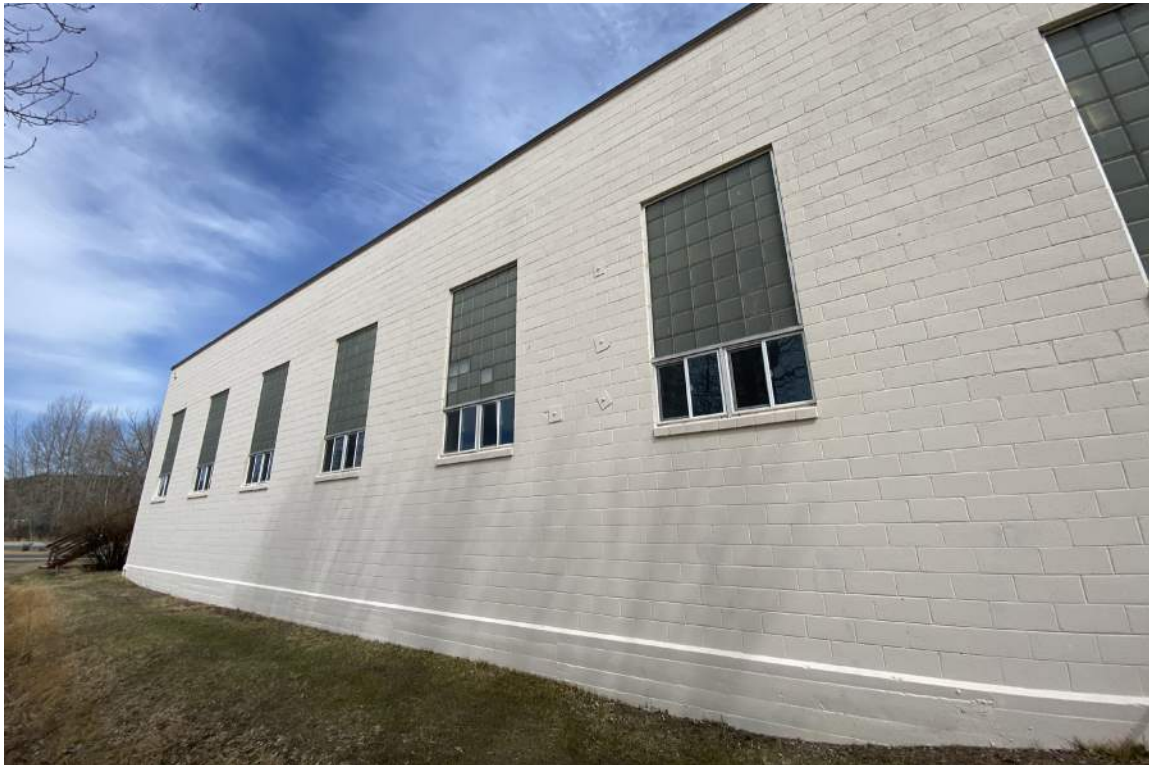
South side of Existing Gym, next to irrigation canal from the Boulder River. Masonry block is holding up well, and paint appears new.

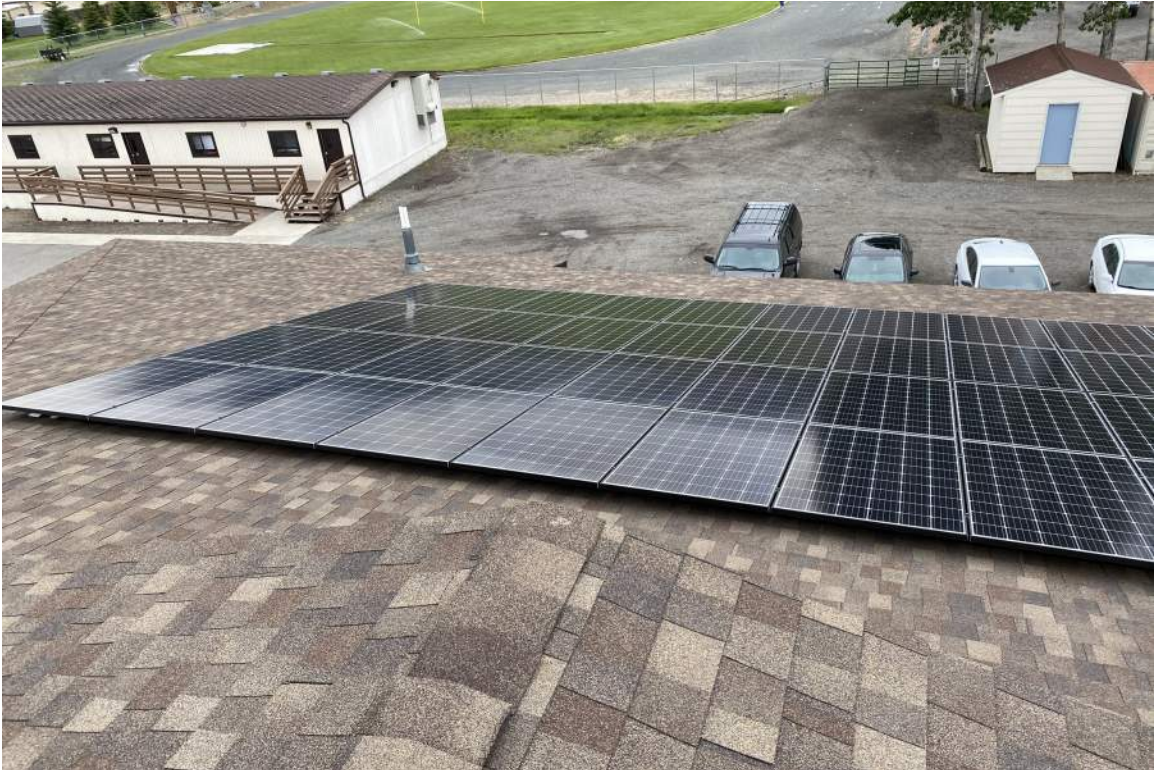
South Library roof, looking towards modulators and storage sheds. Shingles on the Library roof appeared in good condition. Modular roofs had shingles damaged and torn off, mostly from high winds over the previous weekend. Solar panels did not appear damaged.

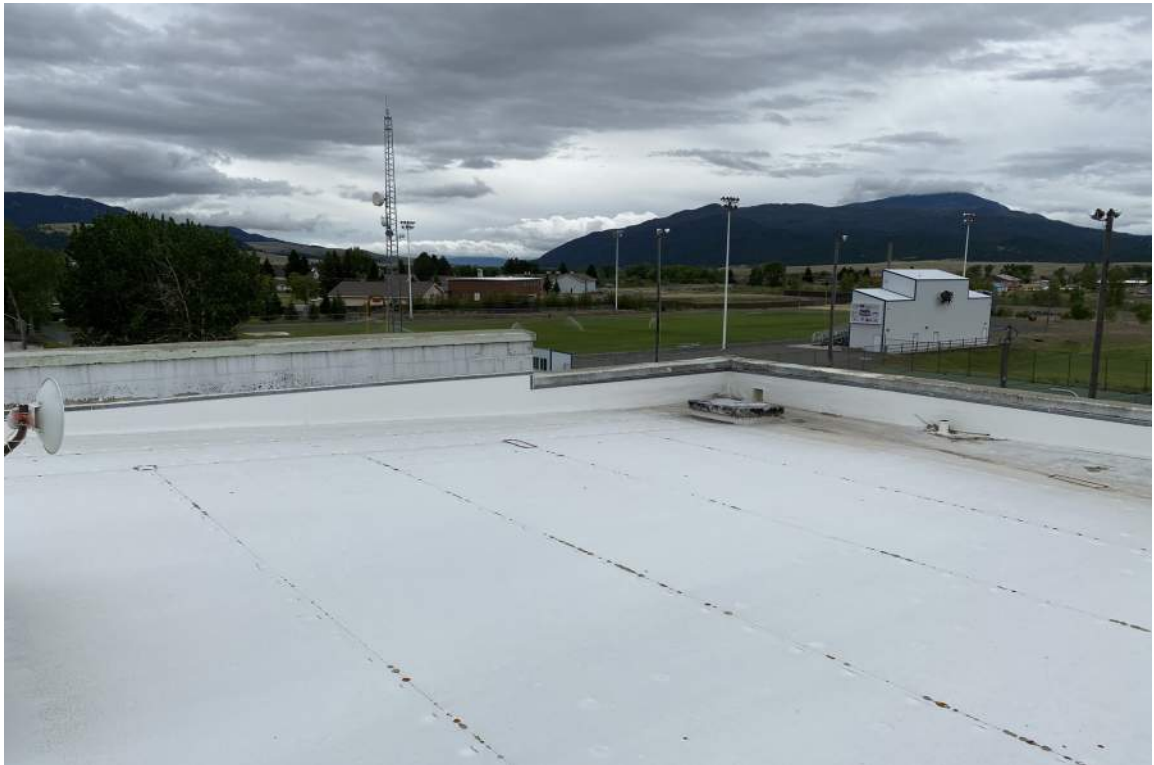
The majority of the existing roofs appeared to be in good condition. This roof, over the Existing (South) Gym, had very little damage and transitions and termination bars were in good working order.

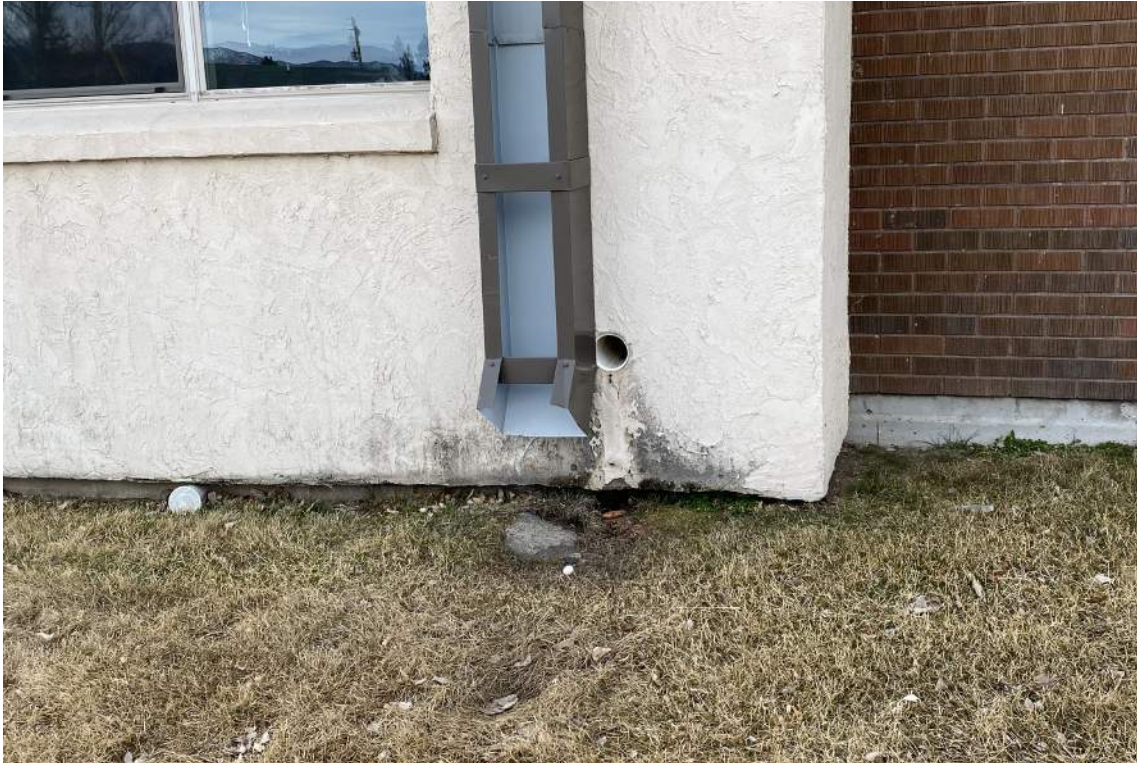
A large roof downspout and overflow on the north side of the building. Most of these large downspouts did not have a splash block or other method of diverting large quantities of water away from the foundation, and most runoff soaks into the grass area.

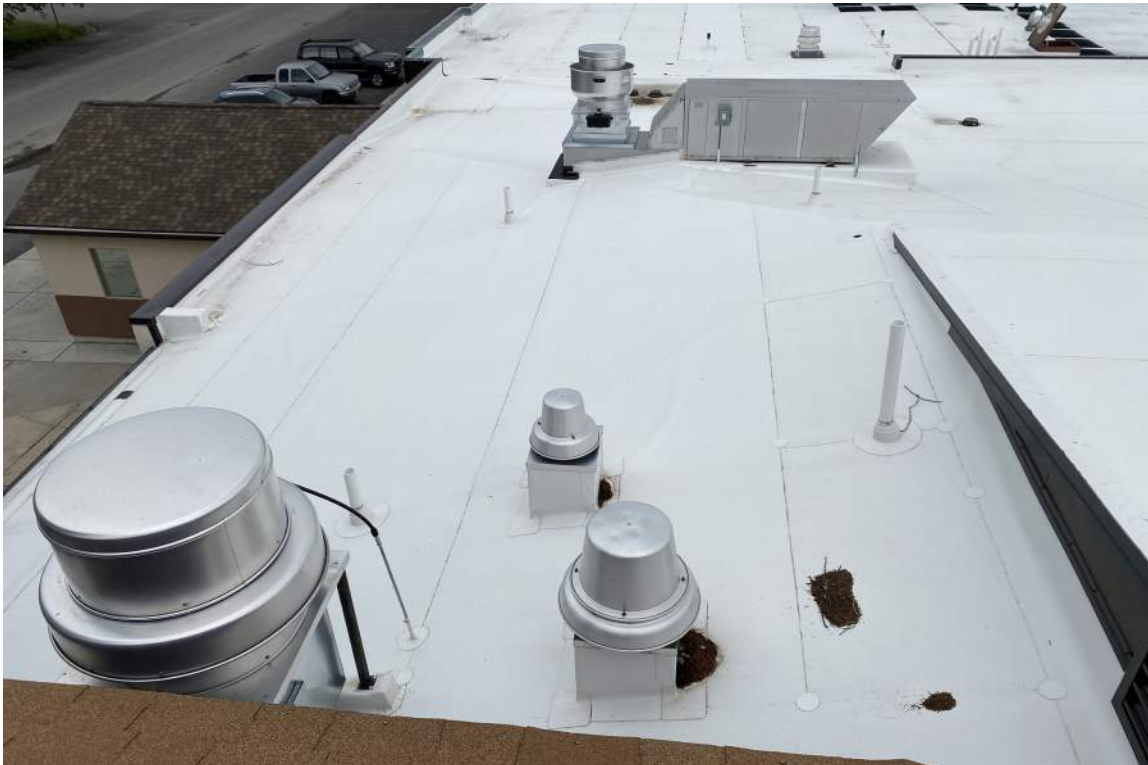
The roof looks relatively new. This area over the Kitchen space had welds and wrapping of membrane applied correctly.

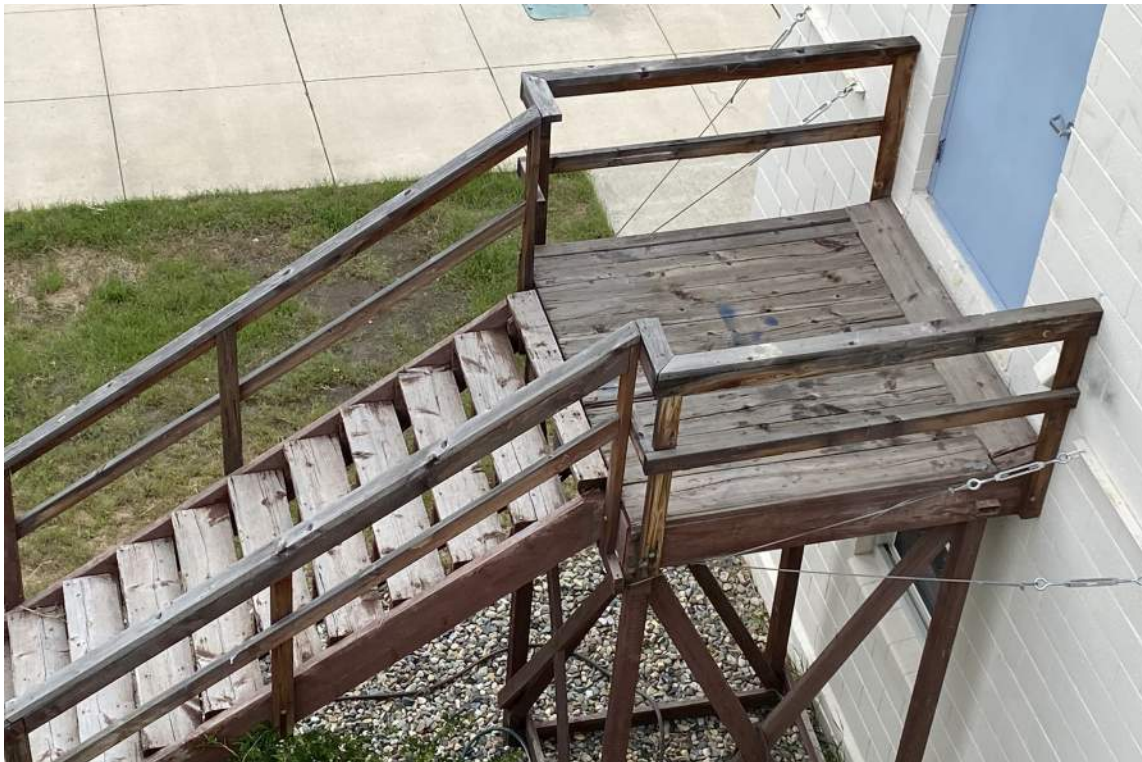
The egress stairs from the Art Room, as seen from the South Gym roof. The wood appears deteriorated and is secured to the building with cables. This stair does not comply with current accessibility codes and needs to be replaced with a more permanent stair.

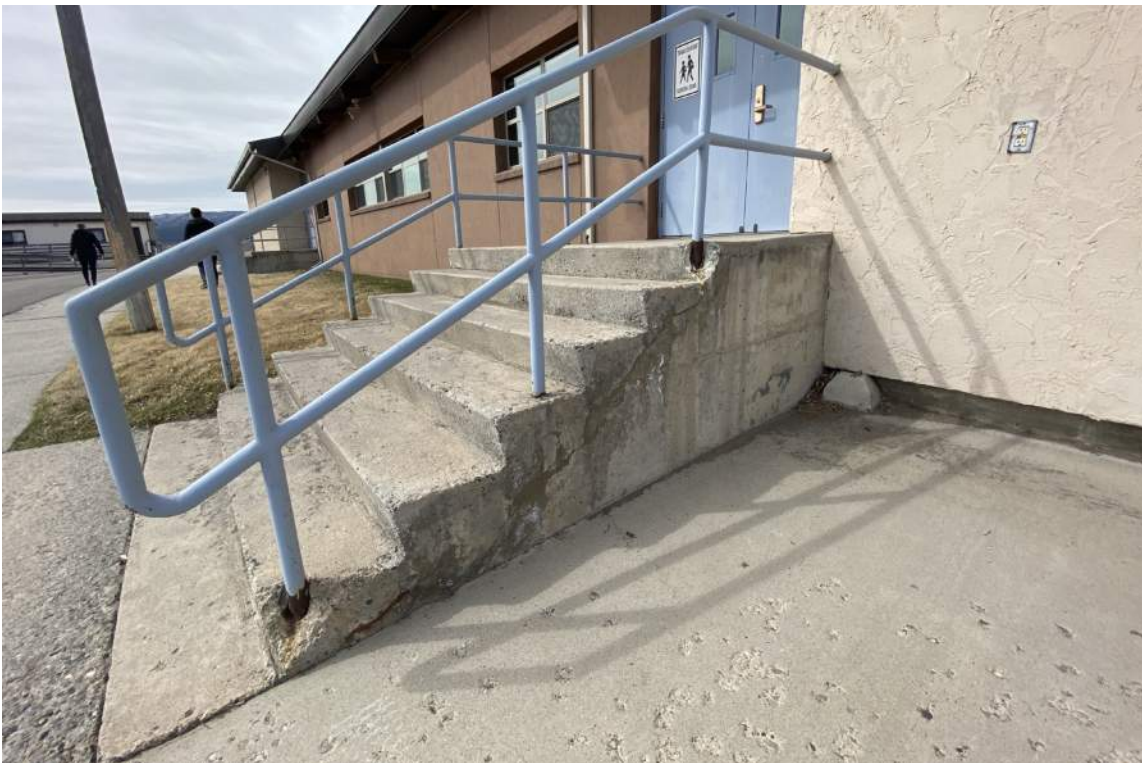
An area of spalling concrete around handrail posts. While not dangerous or against accessibility codes, continued wear will eventually lead to the handrail dislodging from the concrete. This could give way under lateral load when in use and cause injury.

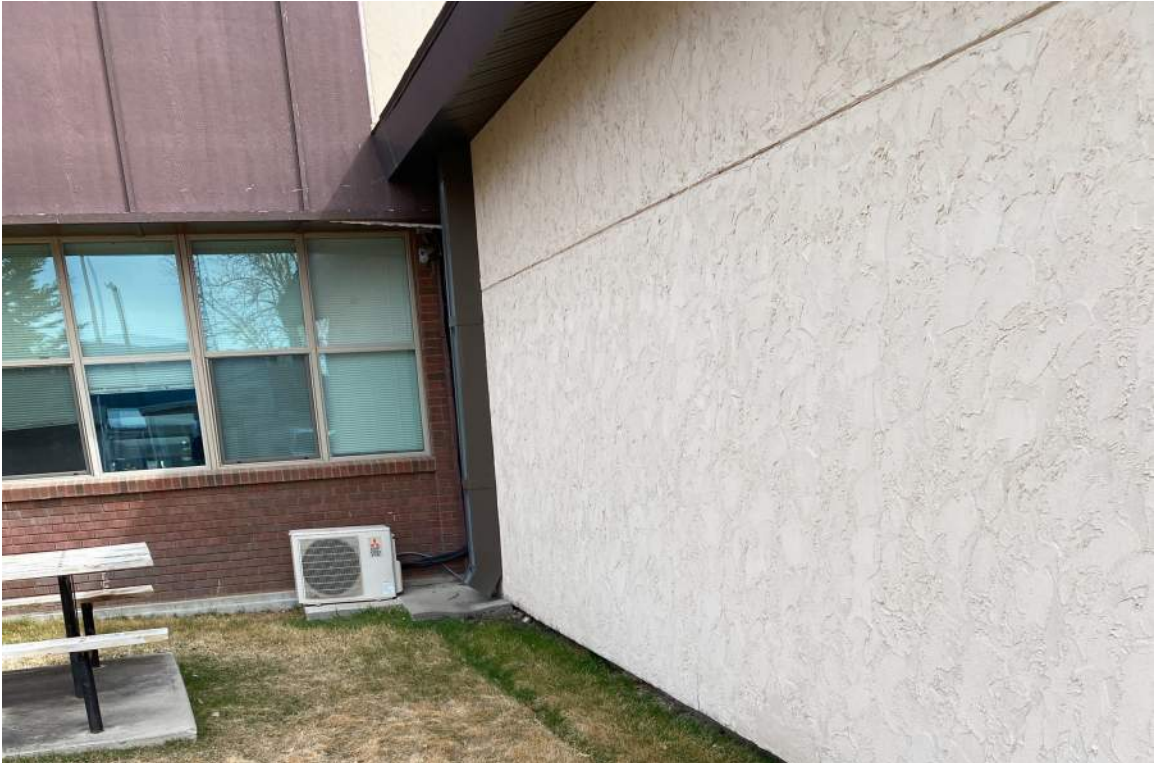
Another large downspout that drains to a splash block in the back of the building. This spout is partially shaded by the wall adjacent to it. During heavy rains, water could flood around the condenser unit here. The drainage swale is visible in the grass leading out to the parking lot. ■

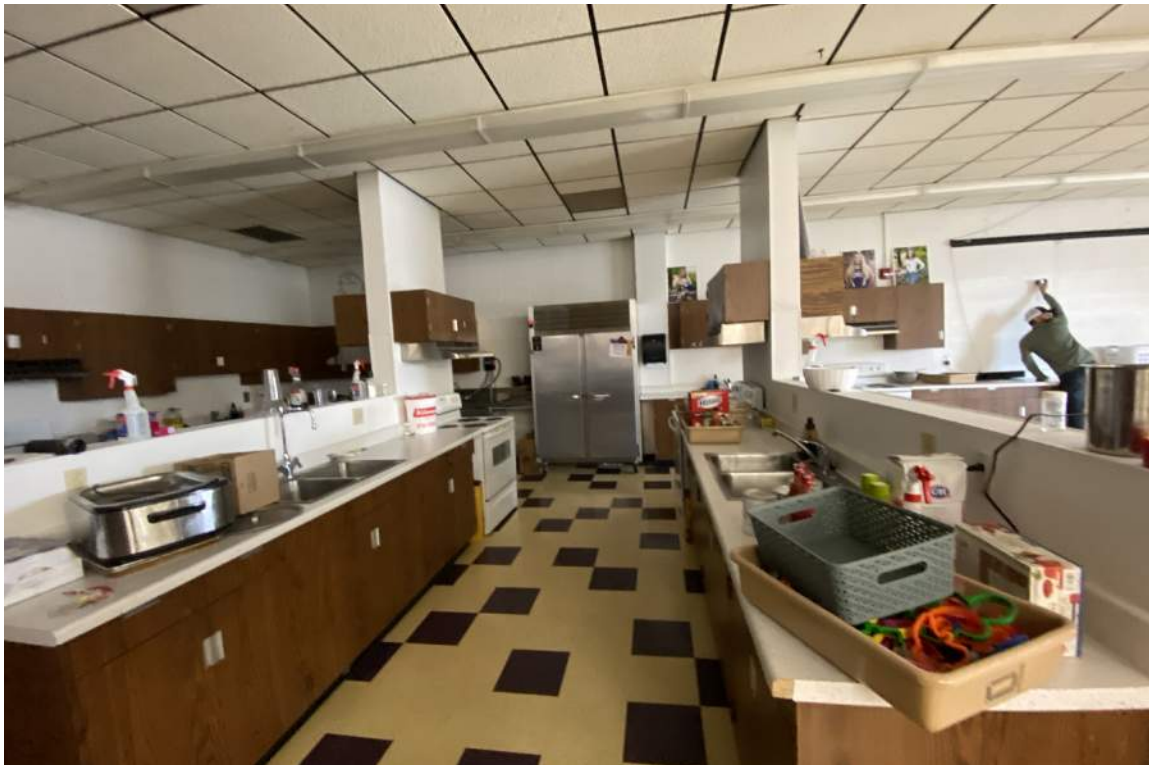
The FCS room. This space was noted to have ventilation problems and the finishes were slightly dated. However, the room had ample space for students and functions.

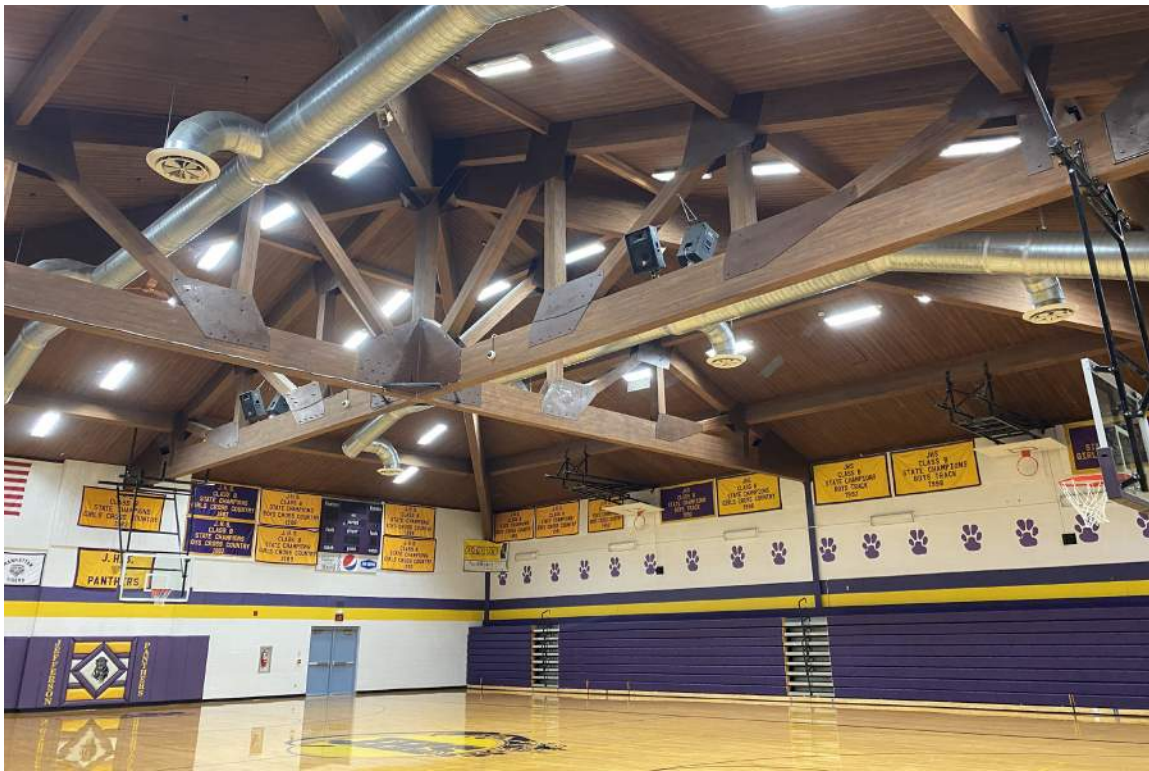
North (New) Gymnasium. Finishes and flooring are new and roof trusses are an attractive touch to this space.

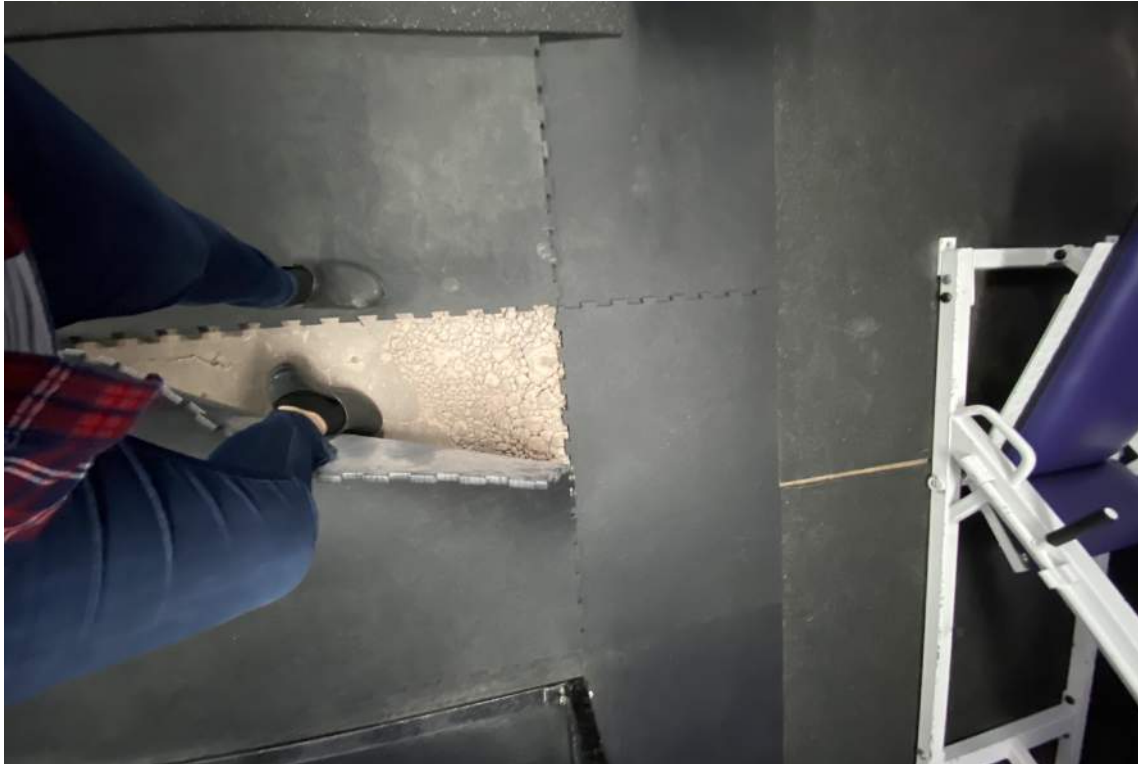
Crumbling composite concrete deck of weight room. Heavy plates and dropping of weights has resulted in severe deterioration of the deck. While this is not a structural problem, it is recommended that the weight room be moved to a floor with a thicker concrete slab.

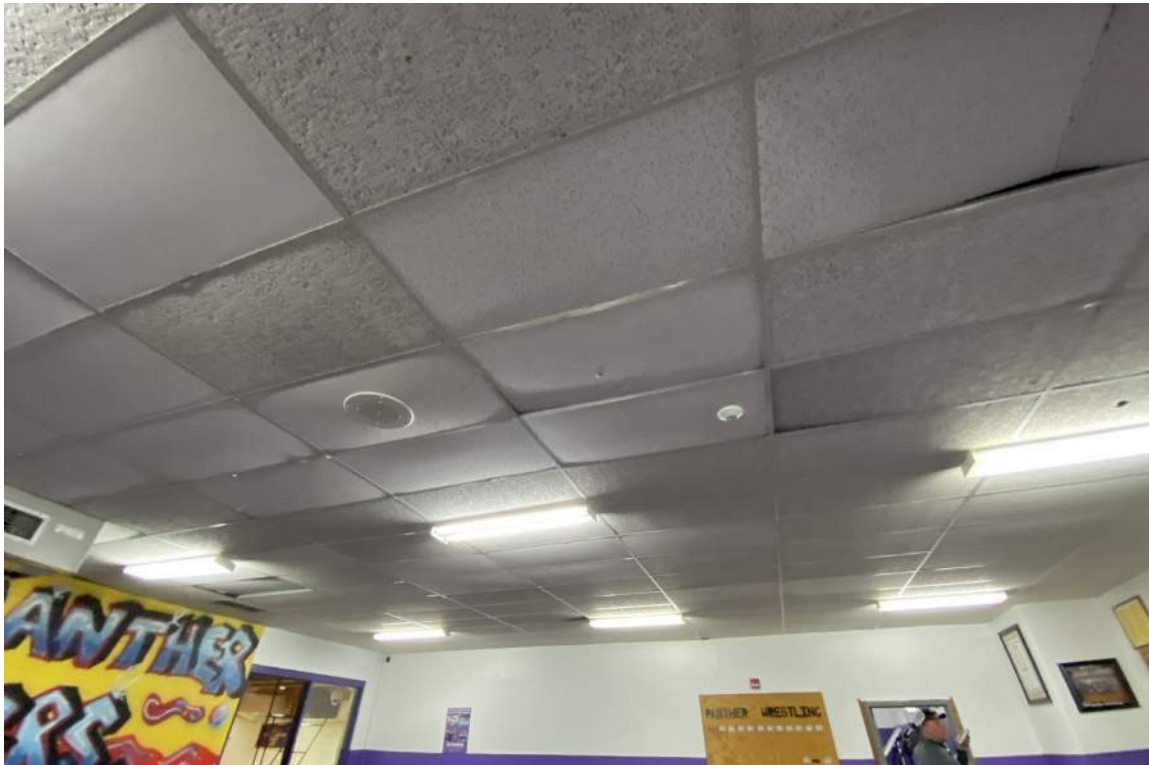
Ceiling tiles in the wrestling room are severely warped and discolored, from previous roof leaks and excessive moisture. Many areas in the school have the same issue and need to have the tiles replaced.

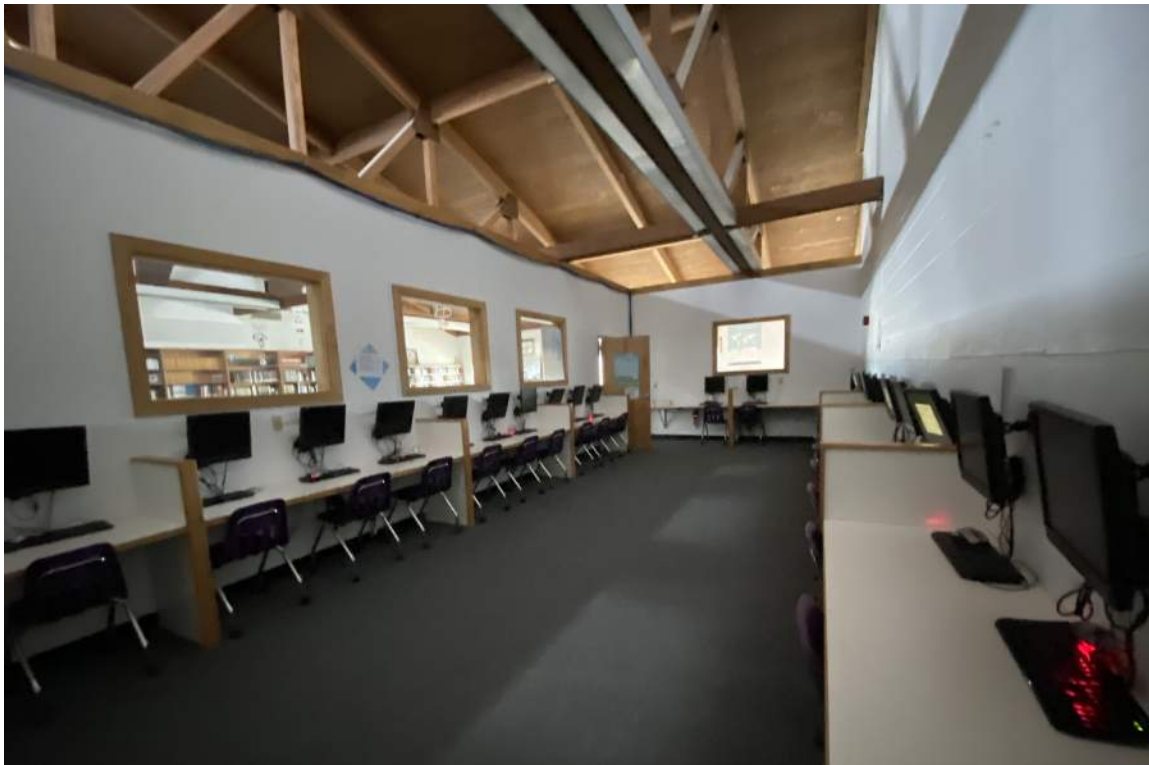
View of computer lab within library space. The large gap above the walls allows sound to travel between spaces.

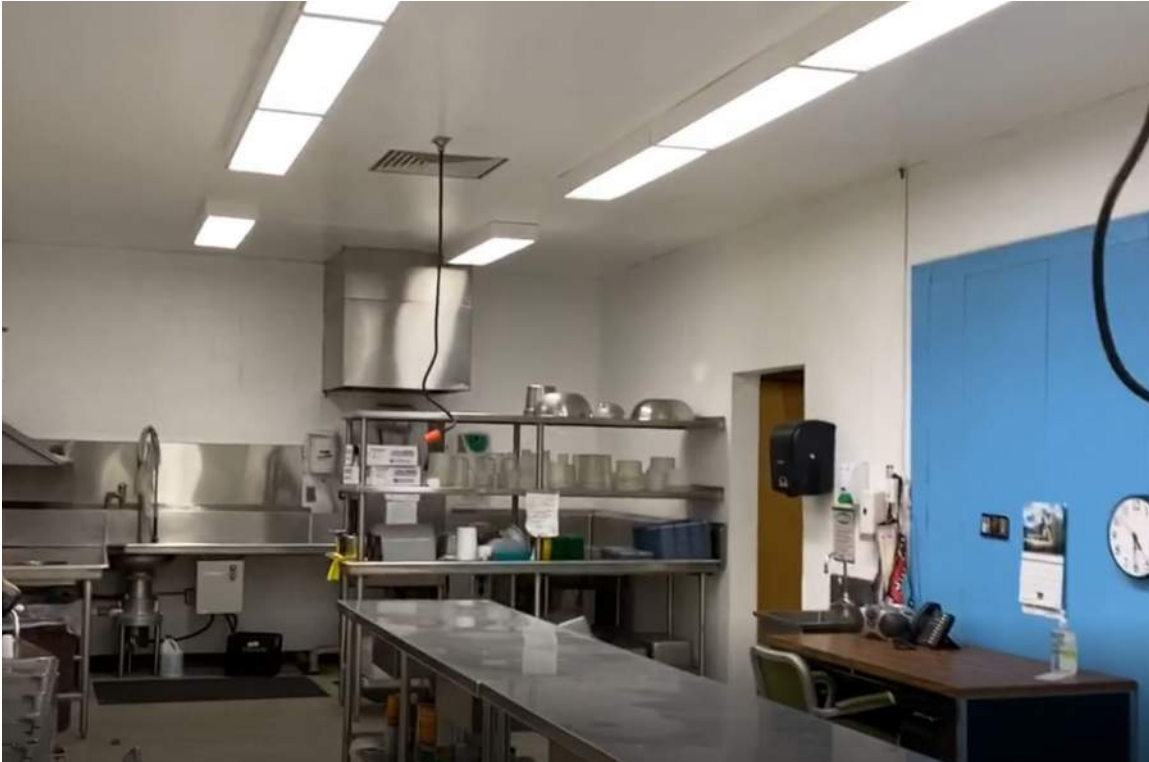
The kitchen dish drop area and prep table. Most of the kitchen equipment appeared to be in good condition.

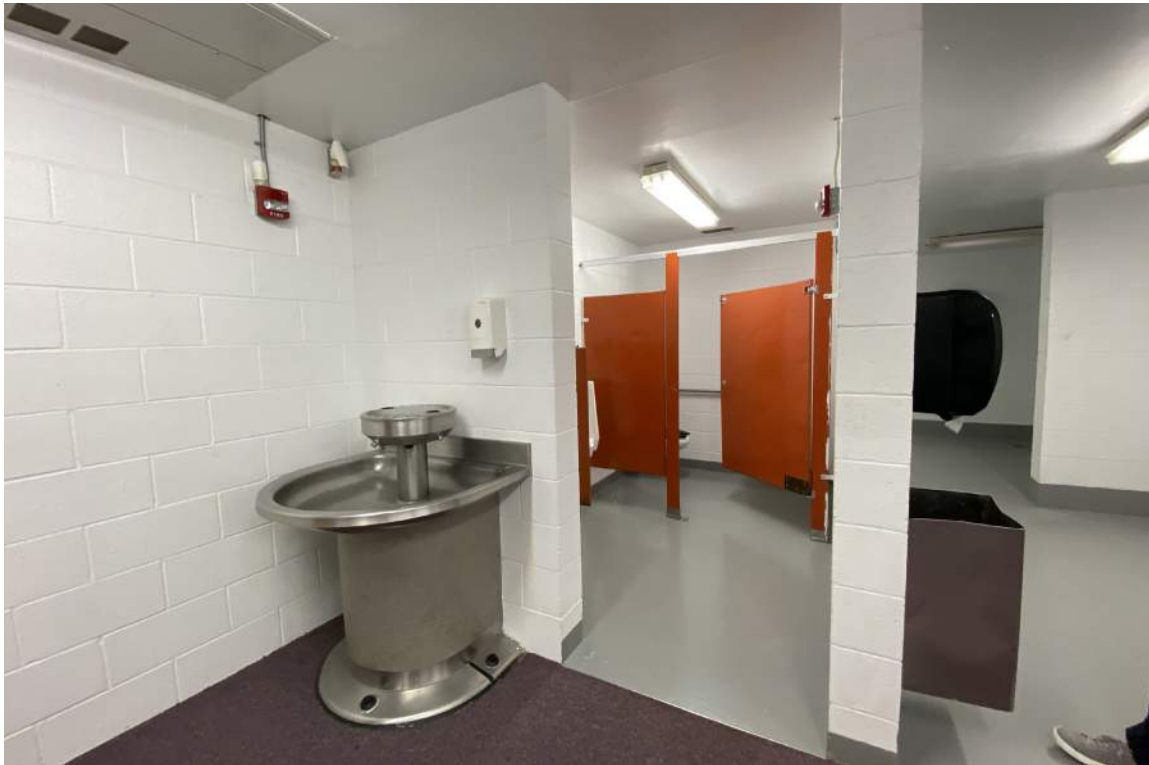
The main floor locker rooms with hand wash station. These stations are designed to serve students around its perimeter, but placement next to the CMU block wall limits access. This reduces the number of required lavatories per the International Building Code (IBC) and amendments per the Administrative Rules of Montana.

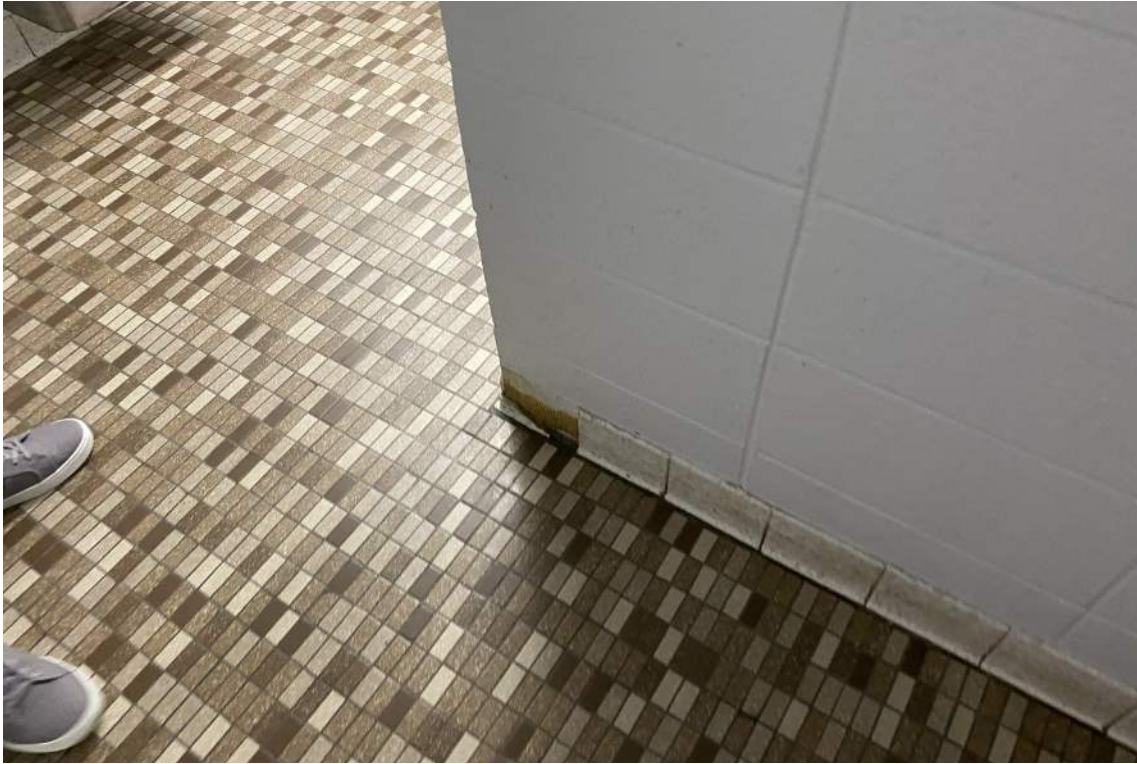
Most restrooms were in good condition, with minor areas of repair needed. However, this CMU block wall makes accessibility difficult for wheelchair users.

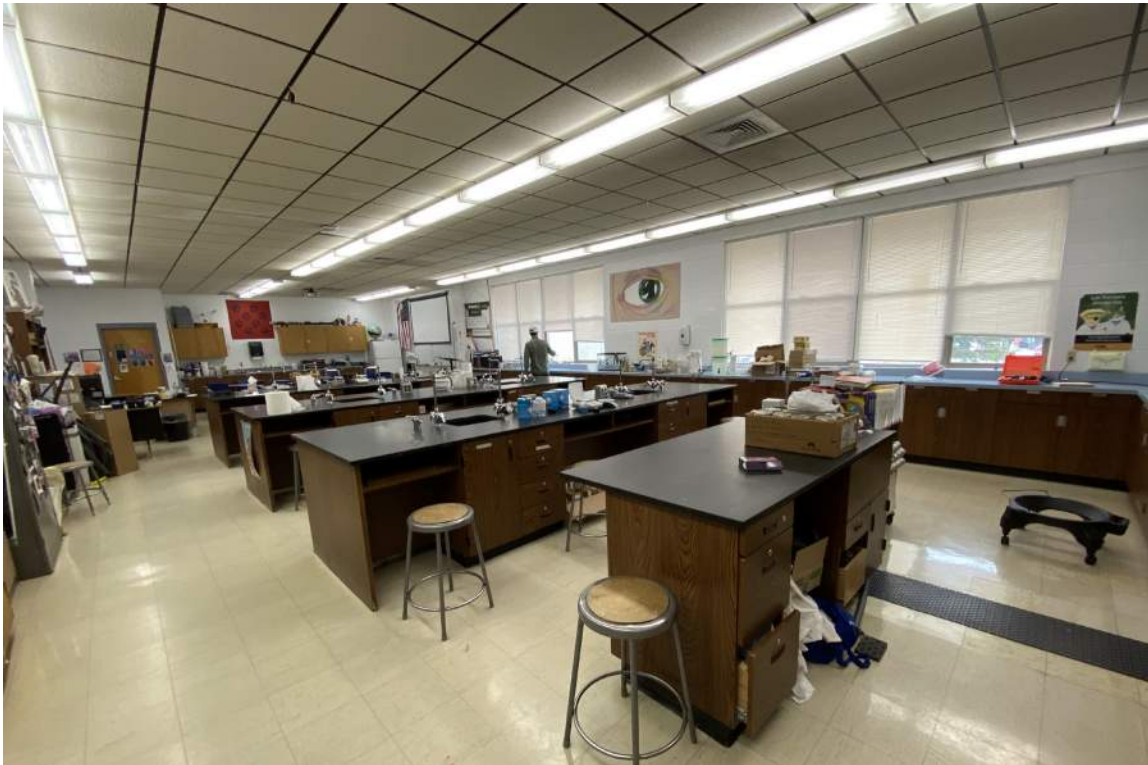
View of the Physical Sciences room. This room is a good size for a science room, based on current design guidelines.

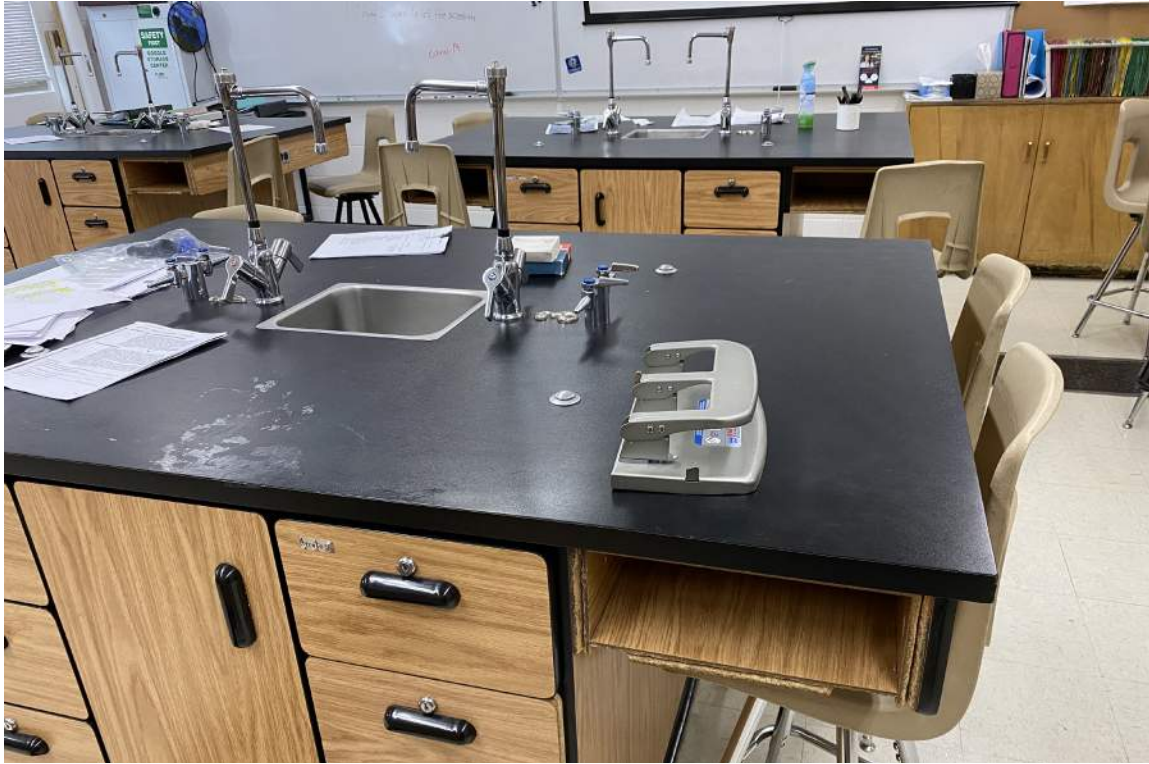
Casework and countertops in the Life Sciences room. While most of these are in good condition, there are areas of wear. This room is too small for a typical science room.

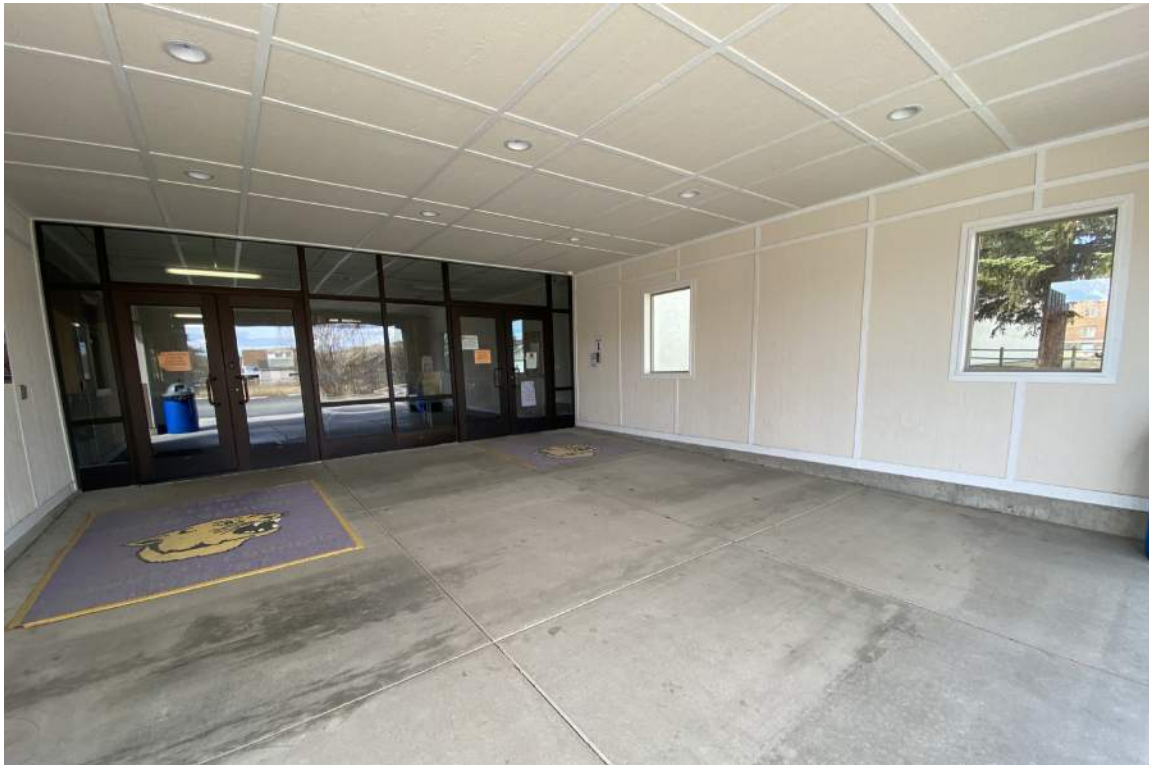
Front entry with overhead canopy and parking, facing East 4th avenue. This large covered entrance provided exceptional weather protection for students entering the building.
