Jefferson High School Building Condition Report

312 S Main Street, Boulder, Montana 59632

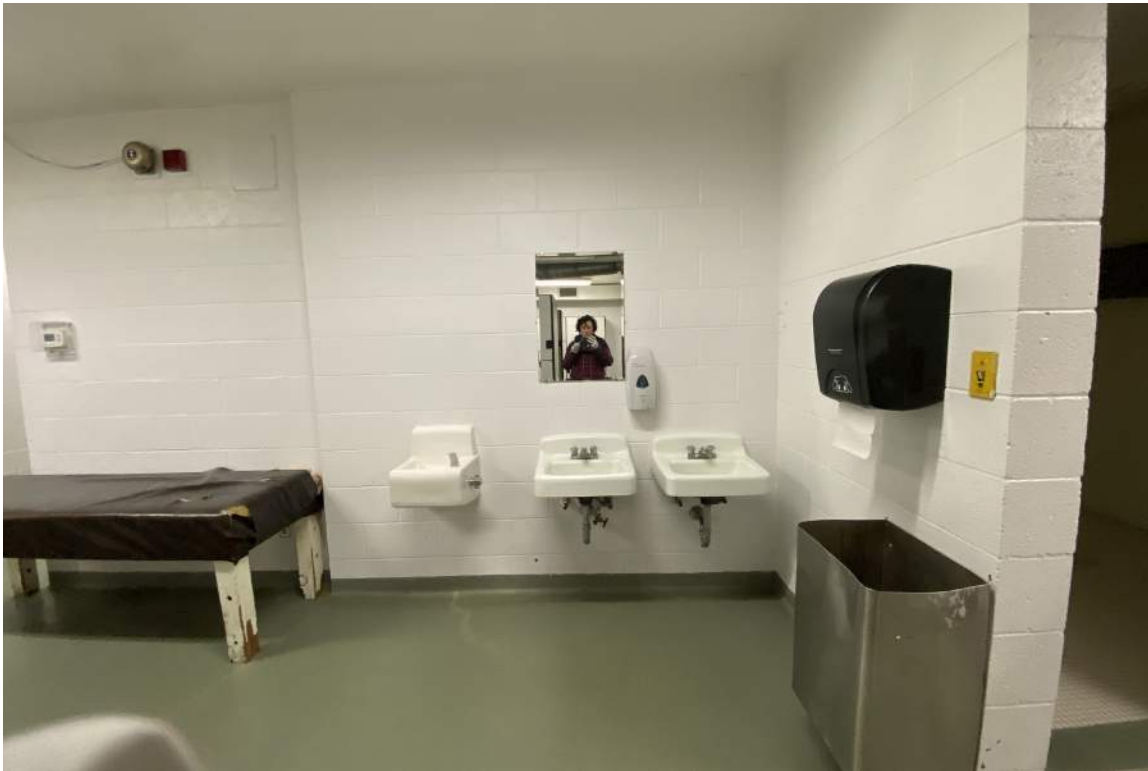
Women's lower level locker room. Floor and walls are in good condition but the training bench is very worn.

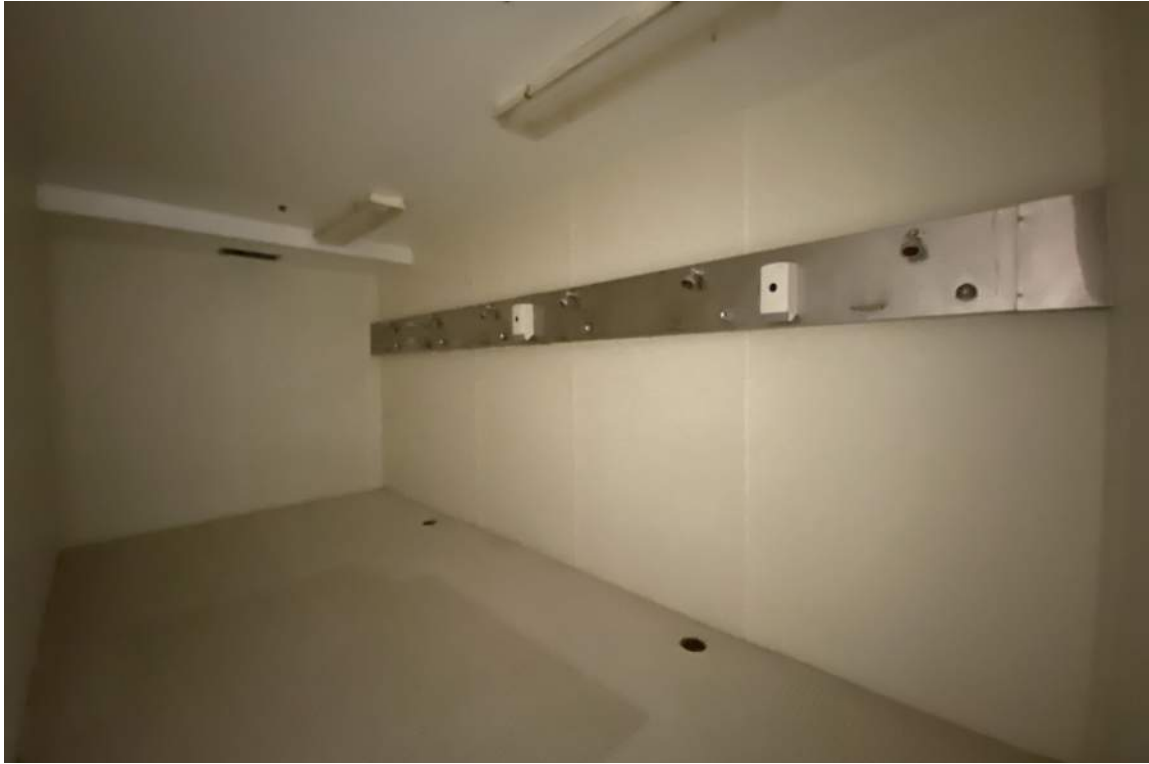
Gang showers in the lower level locker rooms are no longer designed in schools due to bullying and body shaming issues.

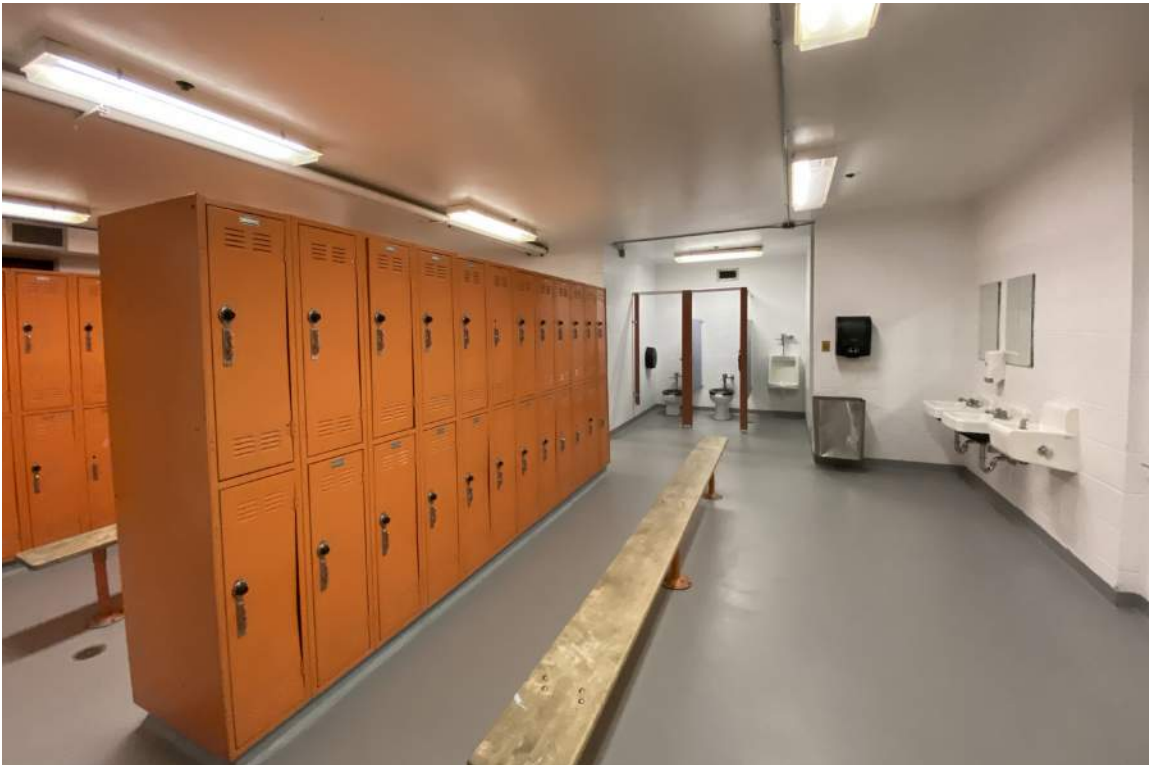
Men's locker room in the lower level of the gym. There are multiple issues in this space, such as accessibility, ventilation problems and doors missing from the stalls. Equipment storage outside this room poses potential Title IX problems.

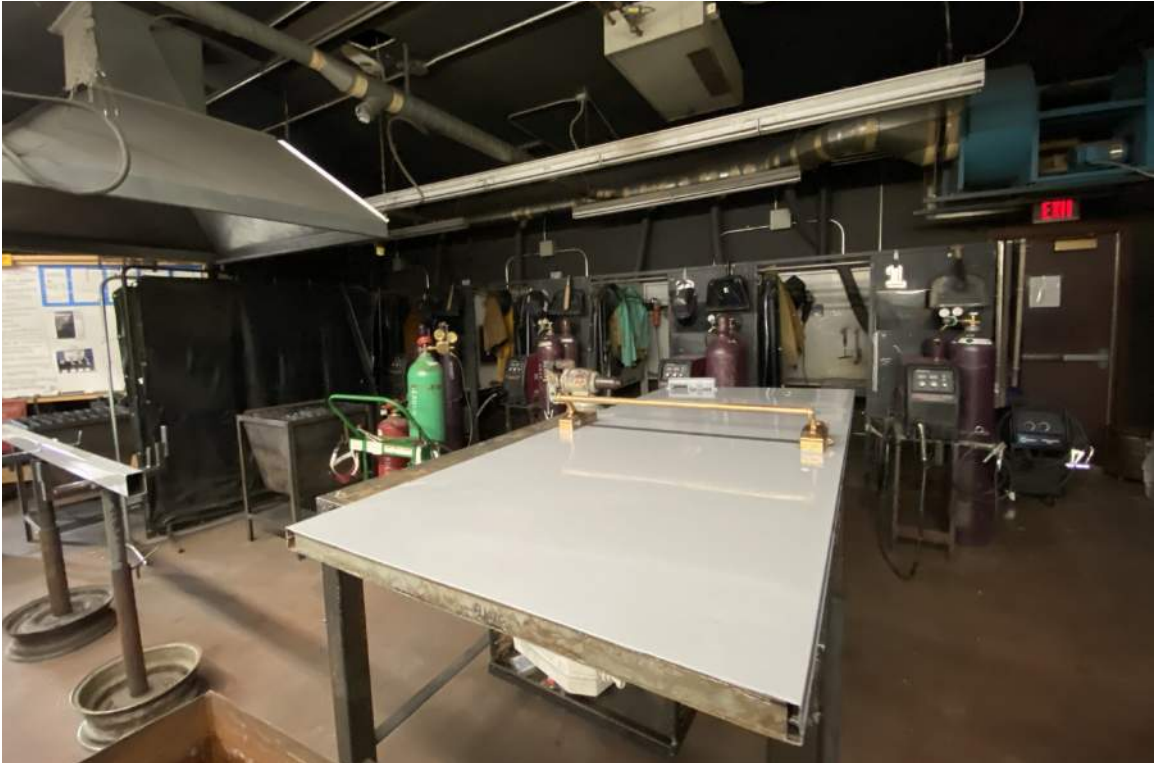
The welding space has a close proximity to the small engines space. Gas fumes are smelled in this room and there are questions of flammability.

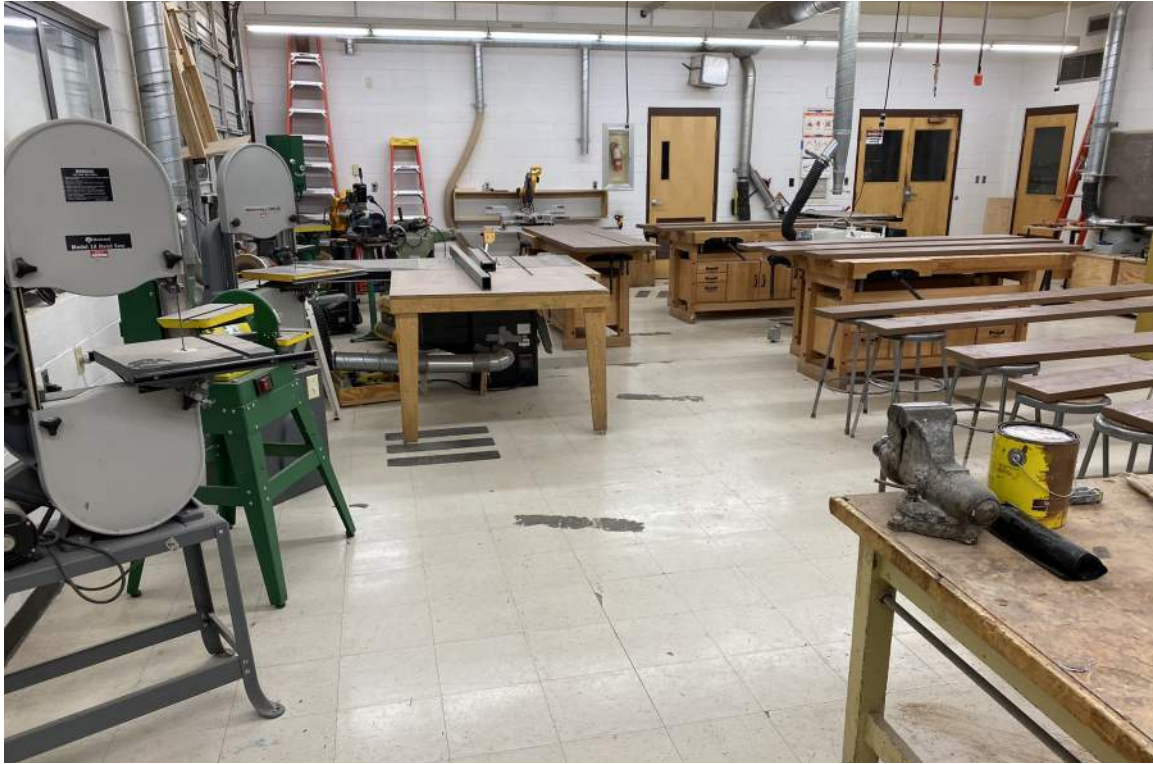
Another view of the shop space. Flooring and tables are worn as expected. The users of this space report slick floor surfaces when covered in sawdust.

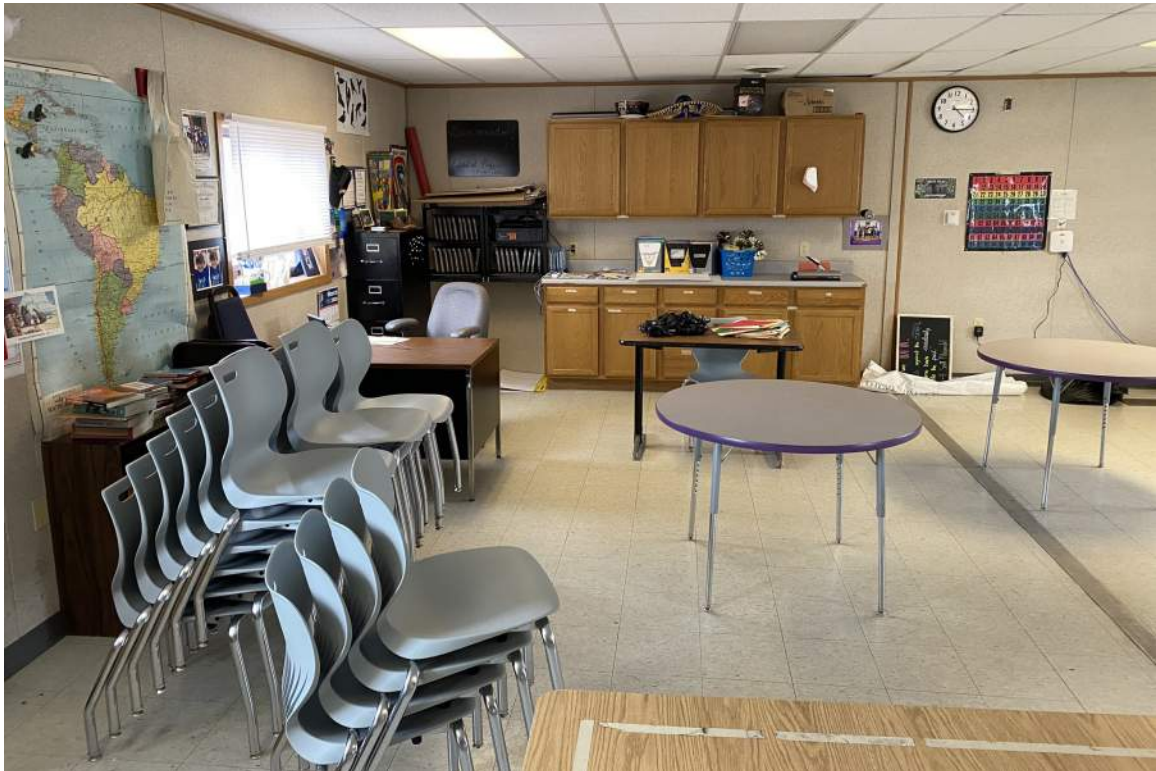
View of one of the modular classrooms. These classrooms are detached from the school building, which poses major security issues.

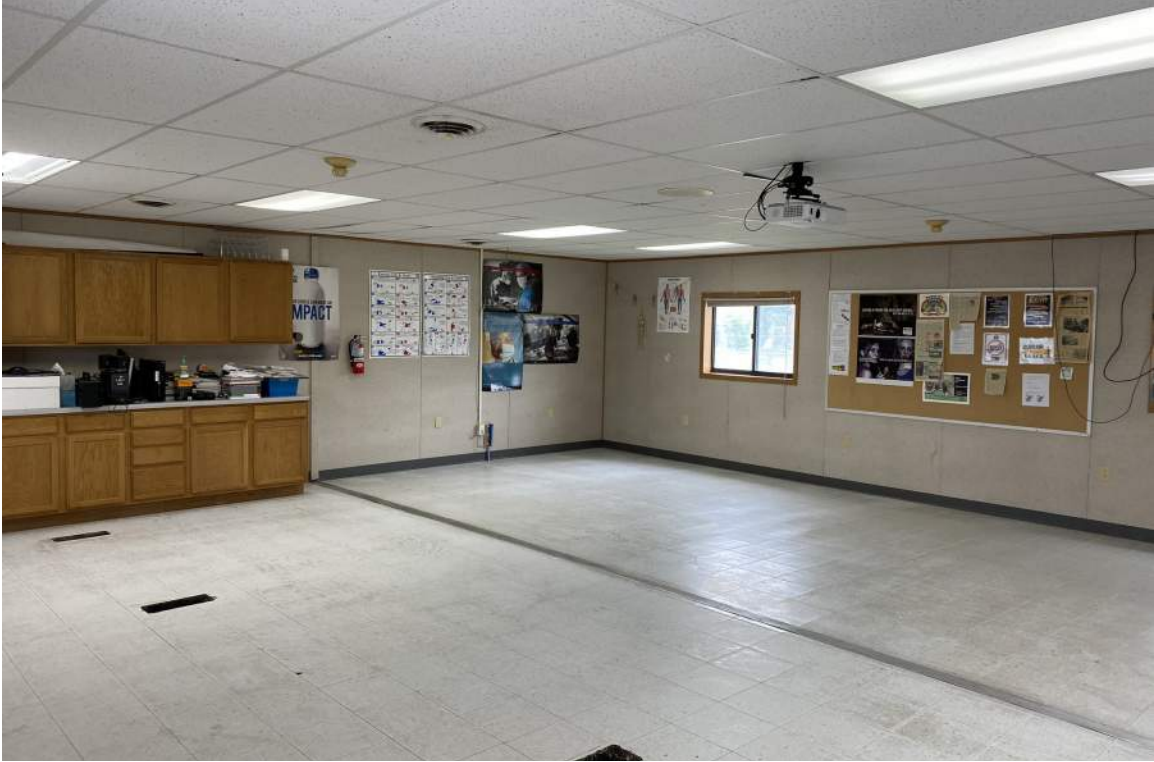
Another modular classroom. Maintenance has been kept up in these rooms and they have floors, ceilings, and casework in good condition. ■

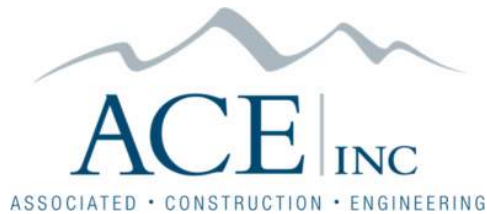
page left blank intentionally

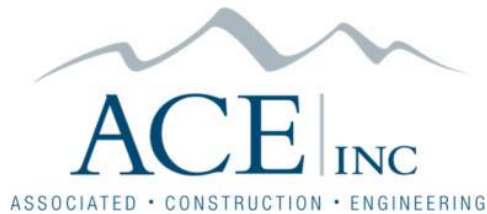
The temperature control system is a combination of older pneumatics and electronic controls and stand alone electric thermostats. Parts availability for the pneumatics is difficult and the controls overall should be upgraded to a DDC system with the heating water control valves replaced.

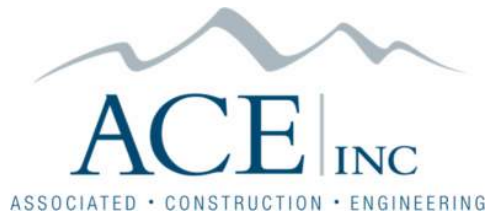
The building does not have a fire protection system installed with the exception of the lower level locker rooms. Looking at the system in the lower level, it is apparent that many of the sprinkler heads are obstructed by adjacent surface mounted light fixtures which should be corrected. Adding fire sprinklers to the entire facility would be expensive and challenging.

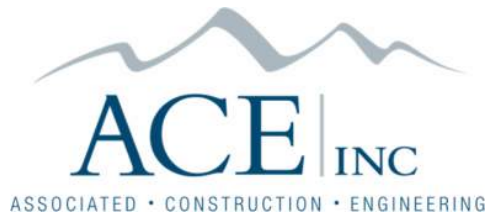
Emergency lighting bug eye lighting in corridors and is lacking throughout some other areas. Certain areas around campus would require emergency lighting systems under current codes. These areas include, but not limited to, exterior areas at exit doors, assembly areas, areas or spaces that are along the path of egress, and spaces with multiple entrances/exits. It is also

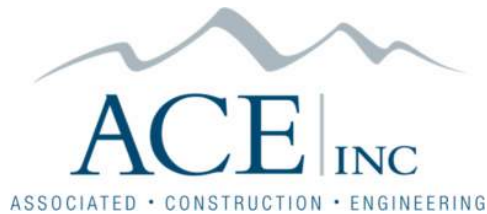
EXISTING FACILITY NARRATIVE

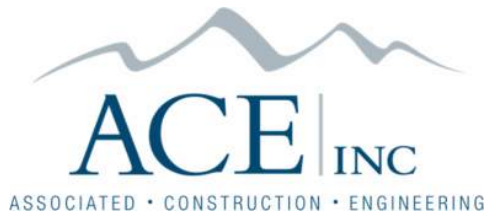
EXISTING FACILITY NARRATIVE

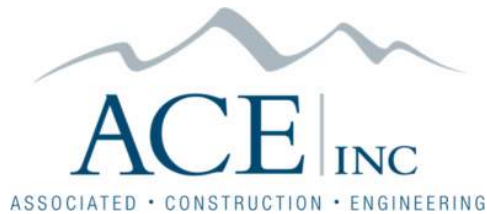
EXISTING FACILITY NARRATIVE

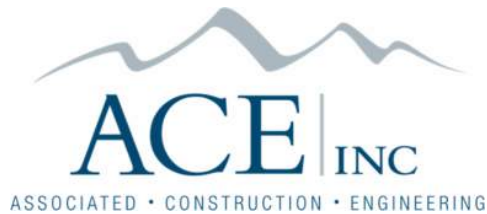
EXISTING FACILITY NARRATIVE

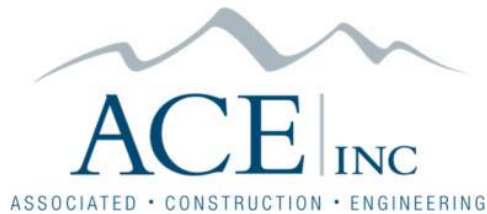
EXISTING FACILITY NARRATIVE

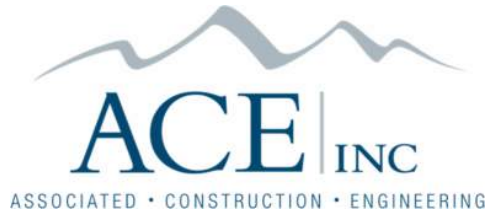
EXISTING FACILITY NARRATIVE

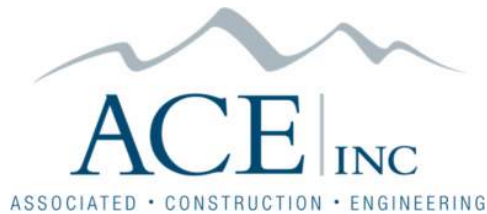
EXISTING FACILITY NARRATIVE

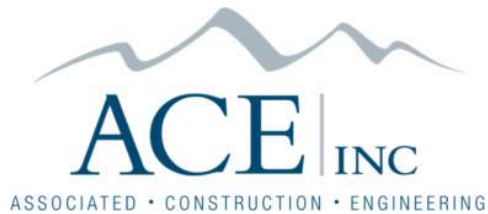
EXISTING FACILITY NARRATIVE

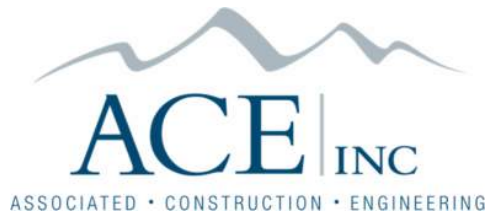
EXISTING FACILITY NARRATIVE

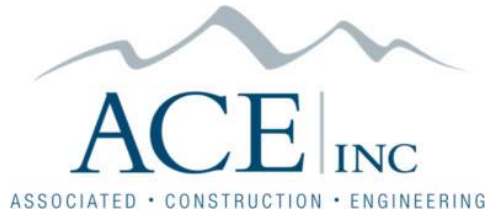
EXISTING FACILITY NARRATIVE

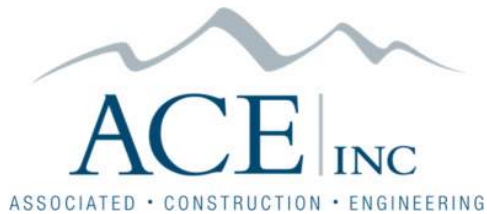
EXISTING FACILITY NARRATIVE

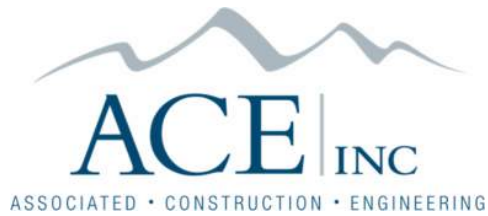
EXISTING FACILITY NARRATIVE

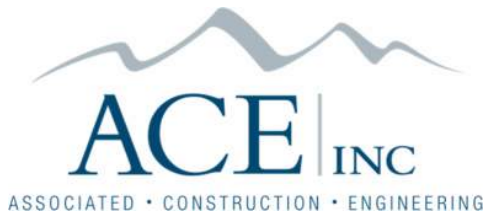
EXISTING FACILITY NARRATIVE

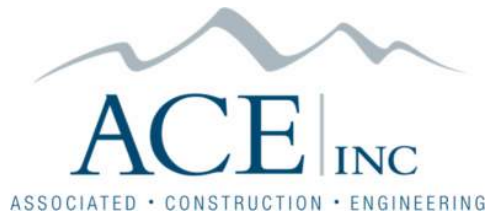
EXISTING FACILITY NARRATIVE

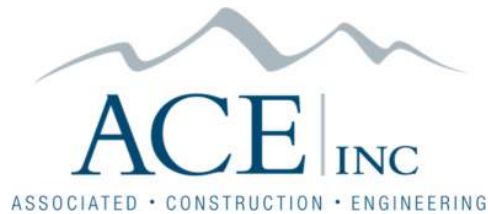
EXISTING FACILITY NARRATIVE

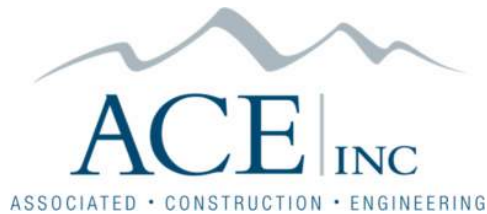
EXISTING FACILITY NARRATIVE

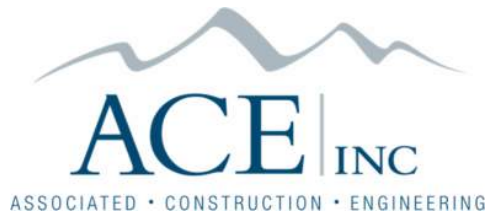
EXISTING FACILITY NARRATIVE

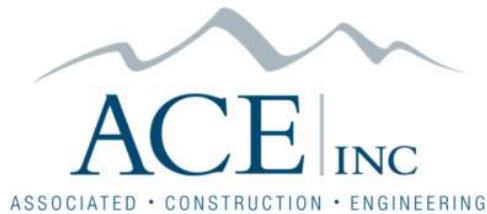
EXISTING FACILITY NARRATIVE

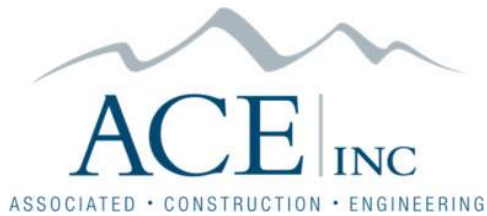
EXISTING FACILITY NARRATIVE

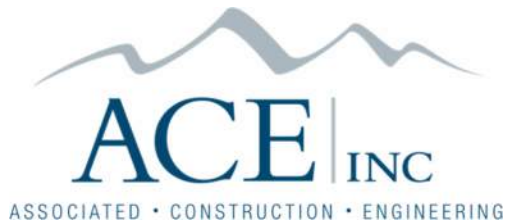
EXISTING FACILITY NARRATIVE

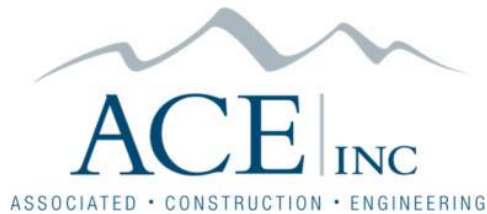
EXISTING FACILITY NARRATIVE

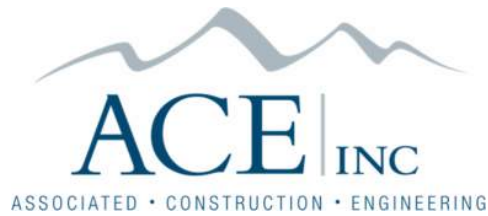
EXISTING FACILITY NARRATIVE

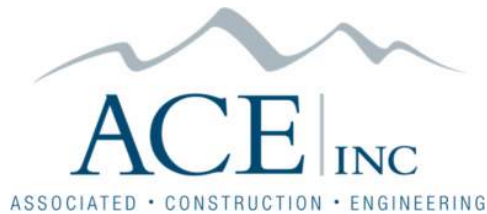
EXISTING FACILITY NARRATIVE

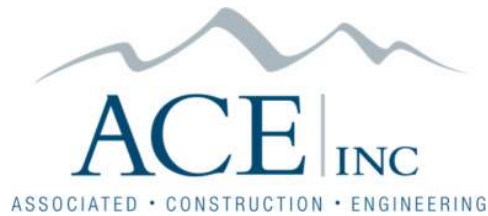
EXISTING FACILITY NARRATIVE

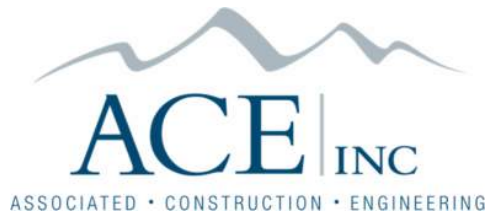
EXISTING FACILITY NARRATIVE

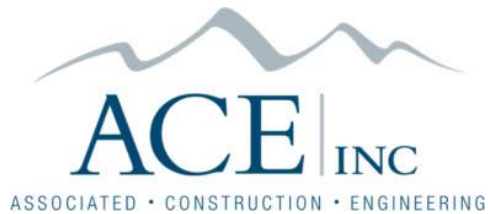
EXISTING FACILITY NARRATIVE

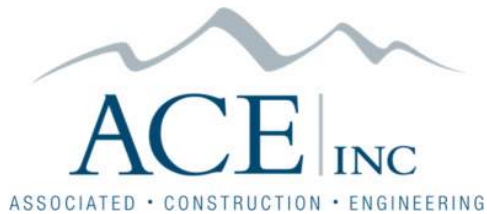
EXISTING FACILITY NARRATIVE

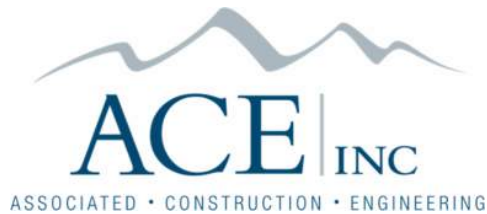
EXISTING FACILITY NARRATIVE

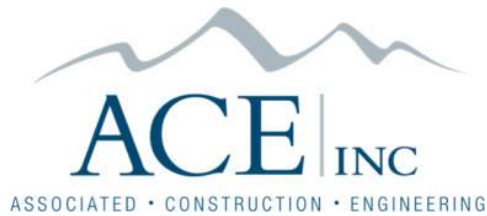
EXISTING FACILITY NARRATIVE

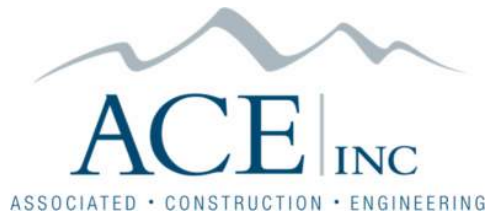
EXISTING FACILITY NARRATIVE

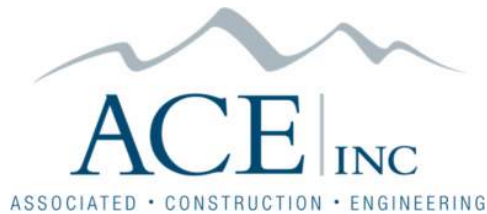
EXISTING FACILITY NARRATIVE

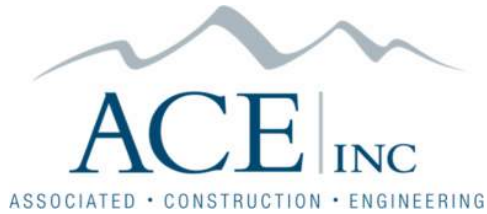
EXISTING FACILITY NARRATIVE

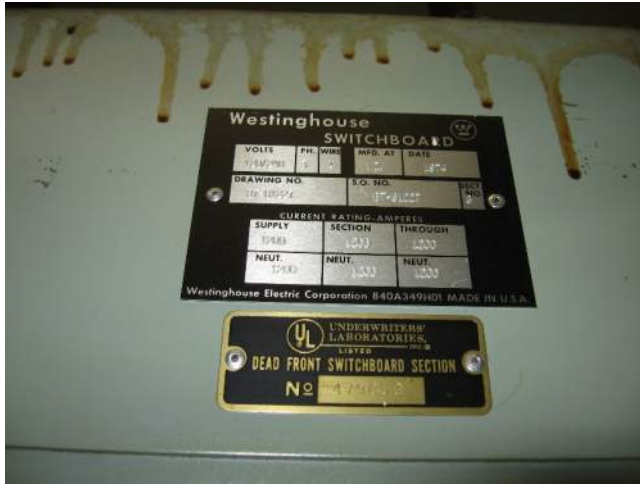
E1: Main Distribution Board showing liquid substance leaking from/onto equipment.

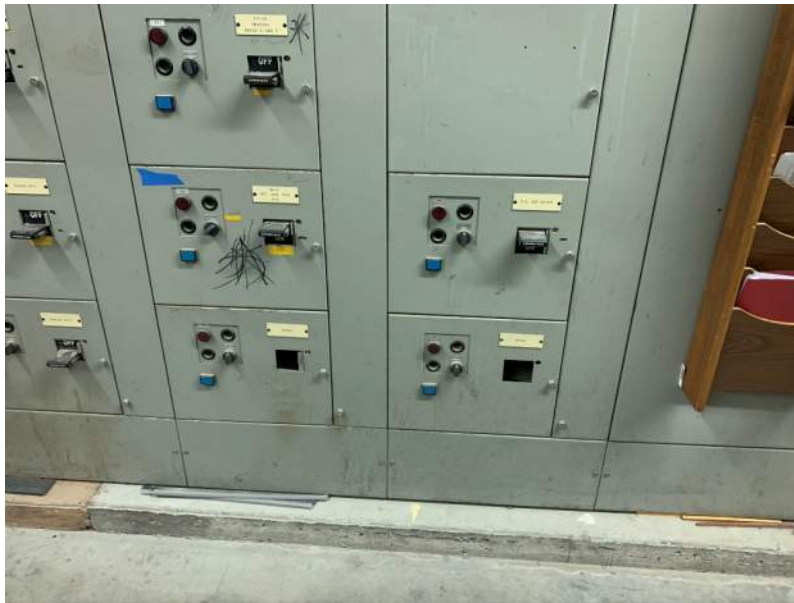
E2: Missing cover plates on MCC buckets need to be repaced.

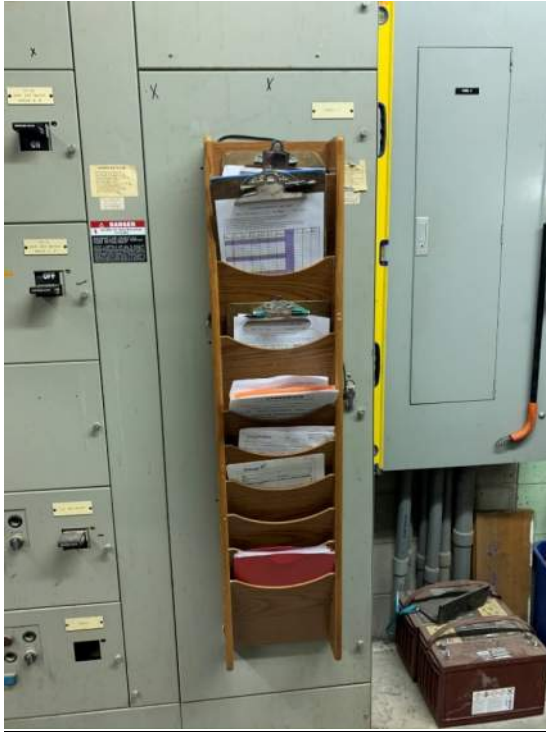
E3: File cabinet mounted to front of Motor Control Center

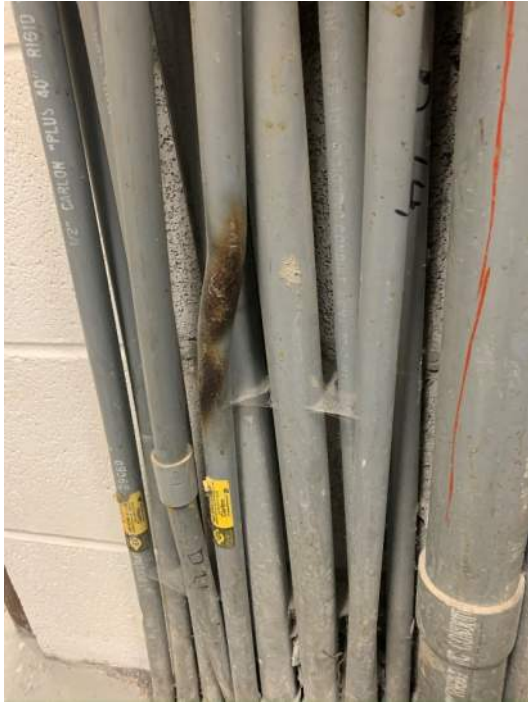
E5: Conduit shows signs of electrical fire and should be investigated by Electrician and replaced.

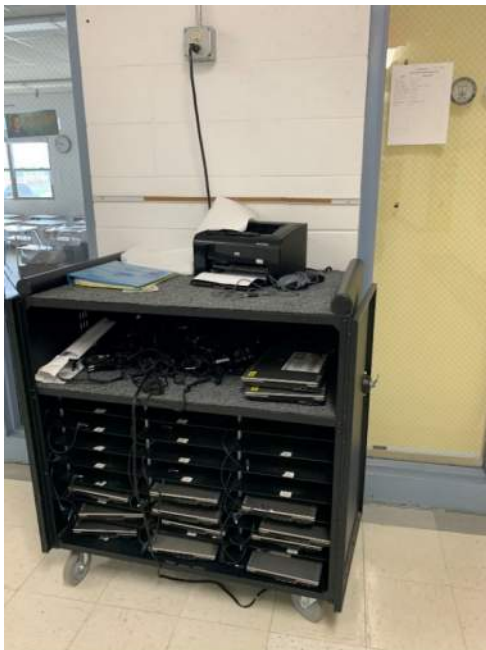
E6: Laptop charging station out in the hallway.

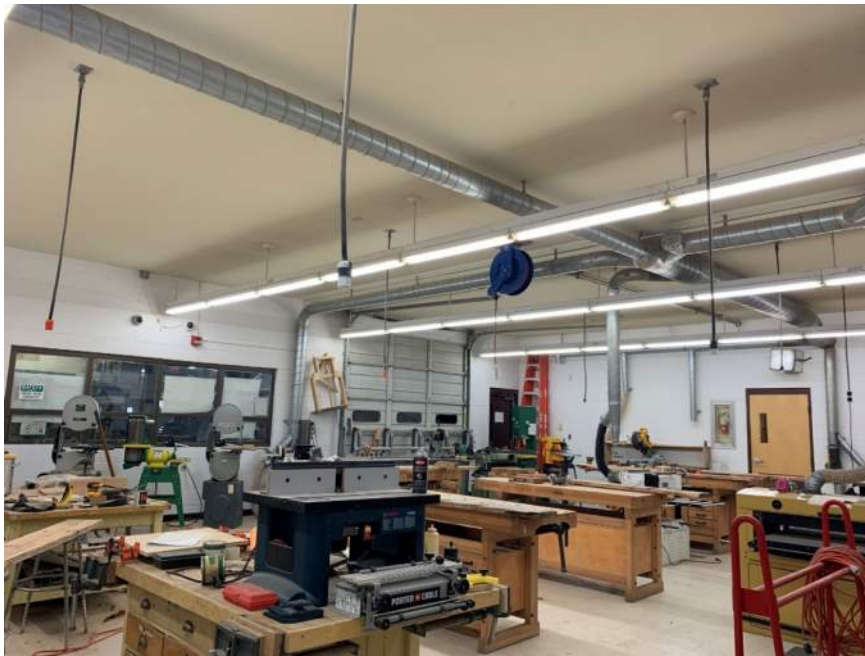
E8: Image of lighting in wood shop. Wire Guards are recommended.

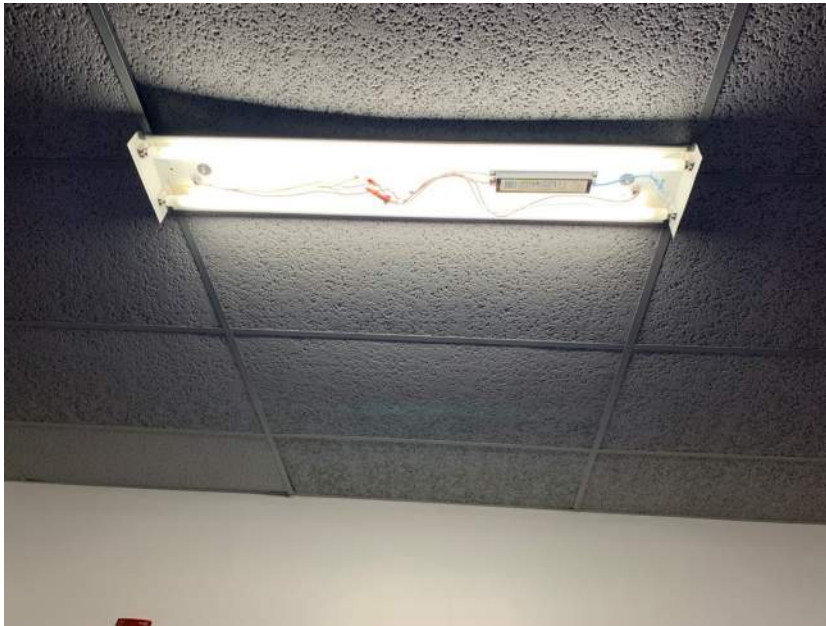
E12: Light in Locker room missing lens

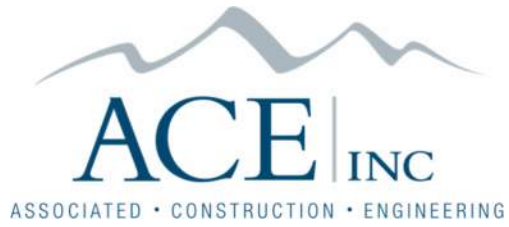
Appendix A: Site Photos - 57

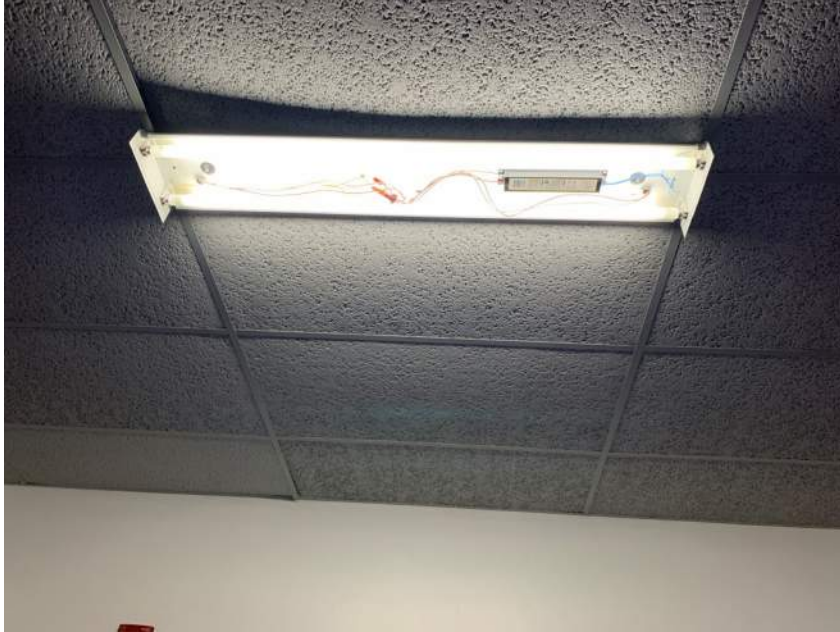
E15: Damaged fixture in weight room.

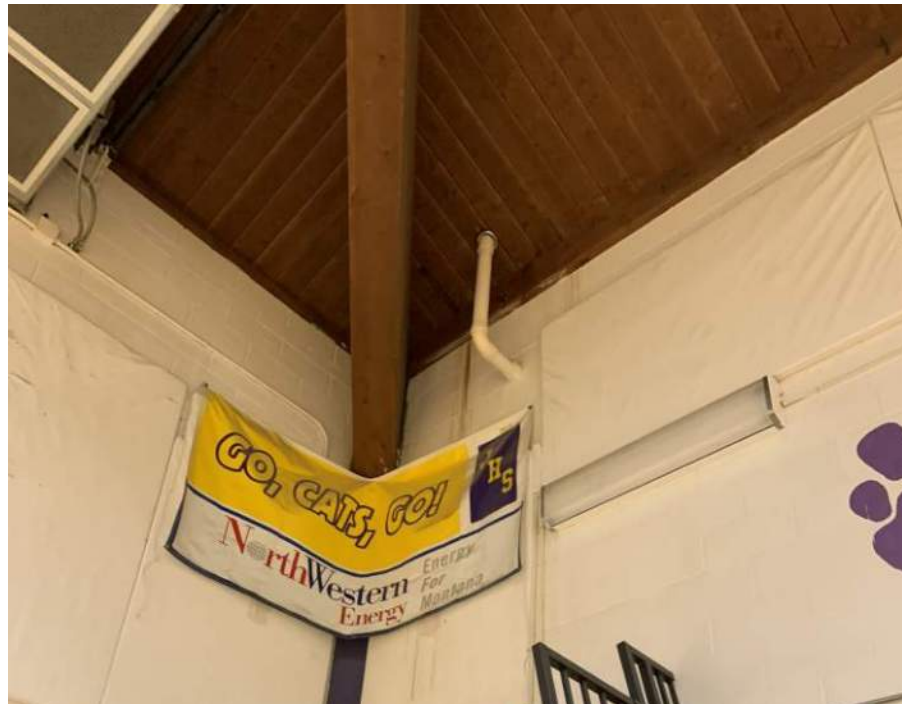
Figure 4. Water Stains on south CMU wall of 1985 Gym

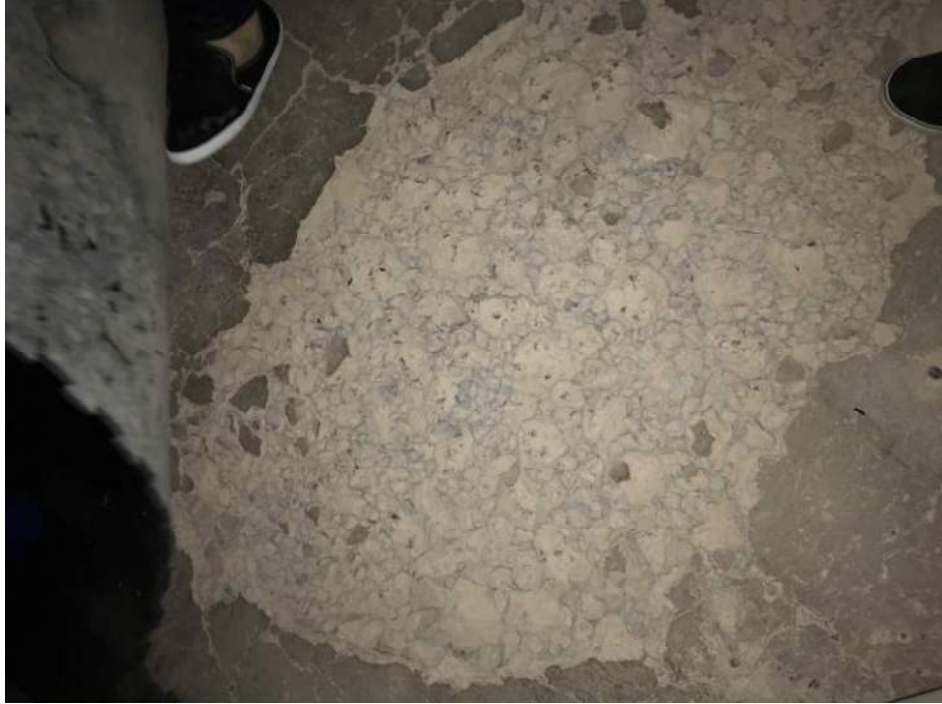
Figure 5. Deteriorated Concrete Floor Slab in Weight Room (1985 Addition)

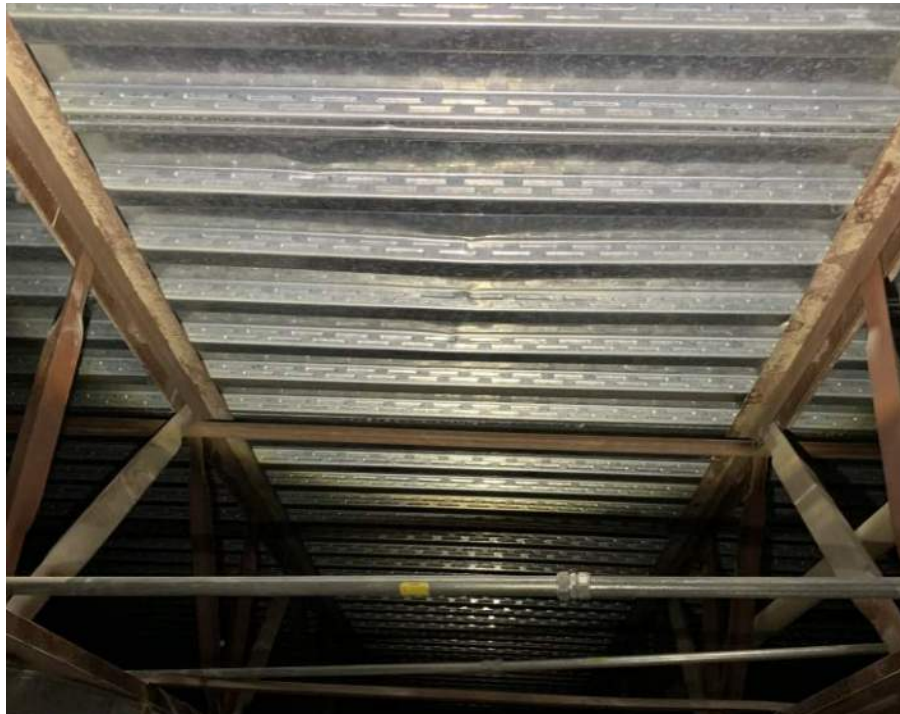
Figure 6. Deformed Metal Deck Below Weight Room (1985 Addition)

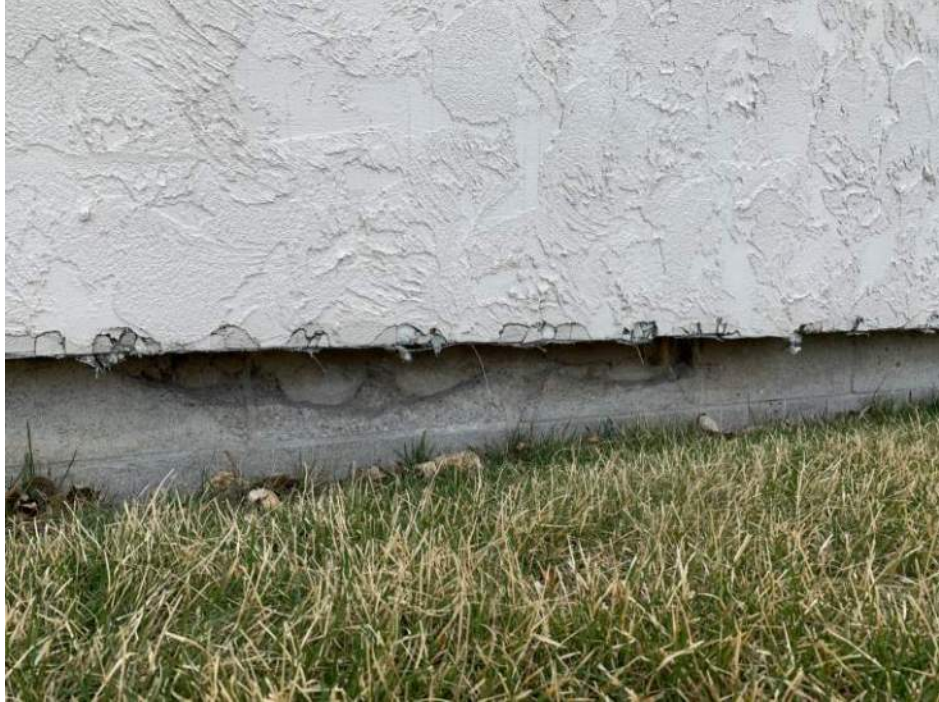
Figure 7. Exterior Foundation Wall Damage at 1985 Gym

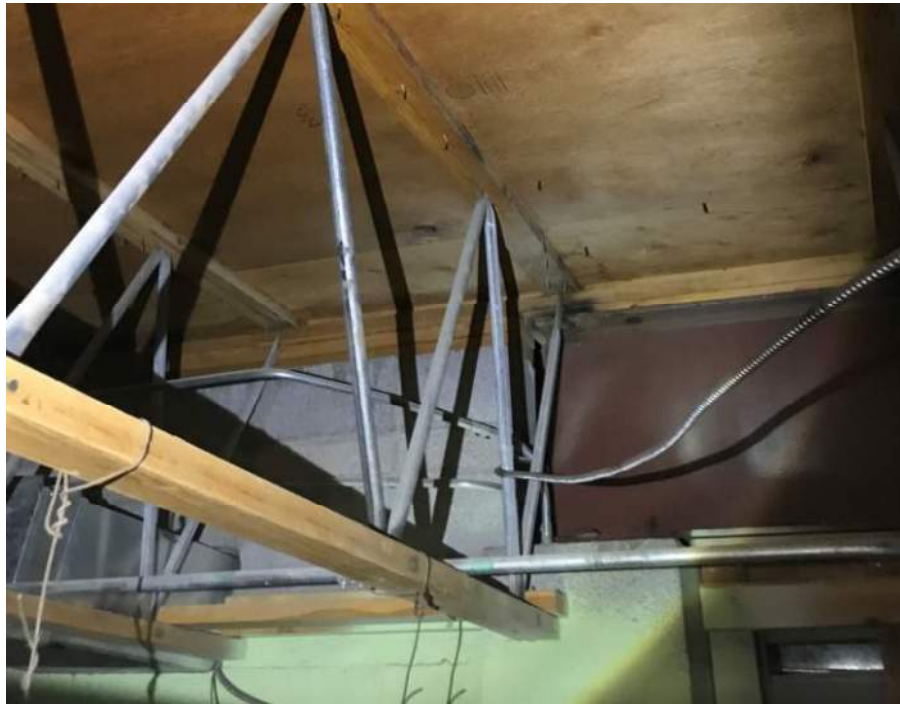
Figure 8. TJL Bearing on Interior CMU Wall (1974 Classroom Addition)

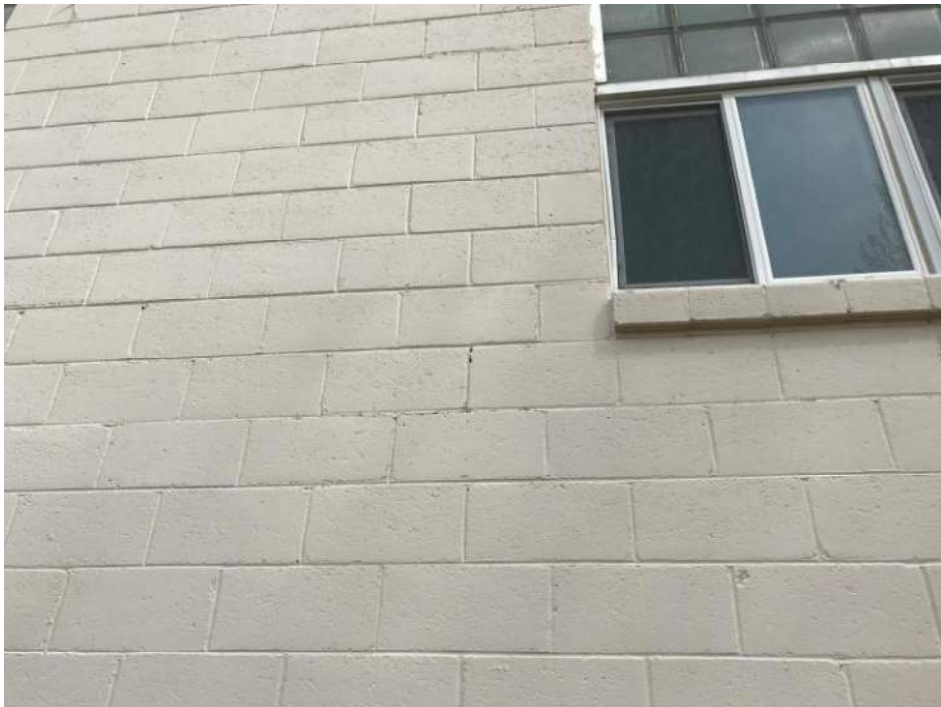
Figure 18. Cracking in Exterior Wall Along Mortar Joints (1956 Addition)

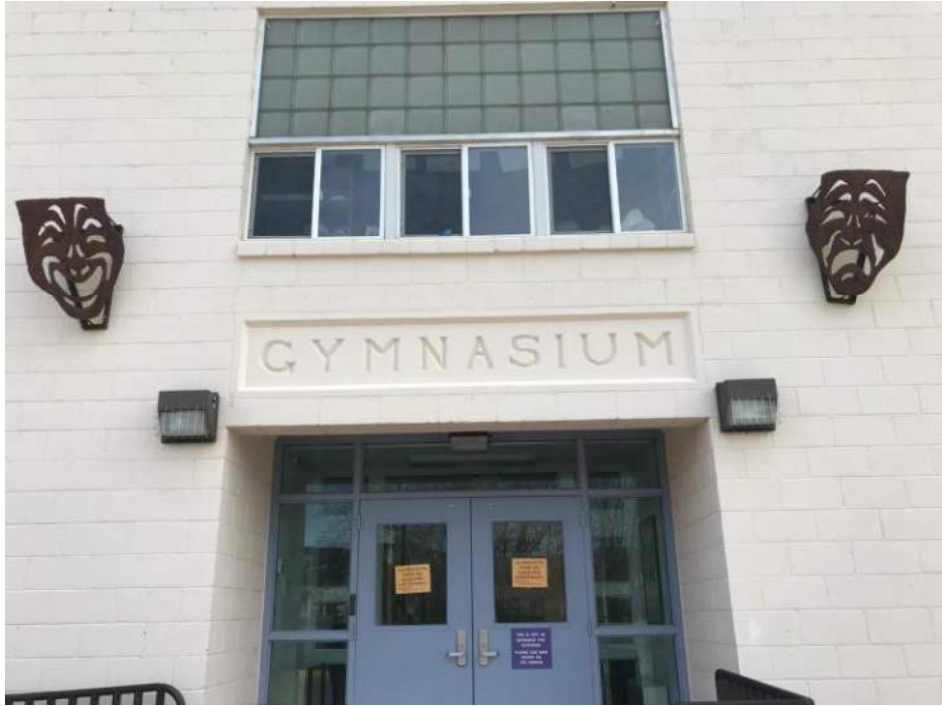
Figure 19. Cracking in Exterior Wall Around Plaque (1956 Addition)

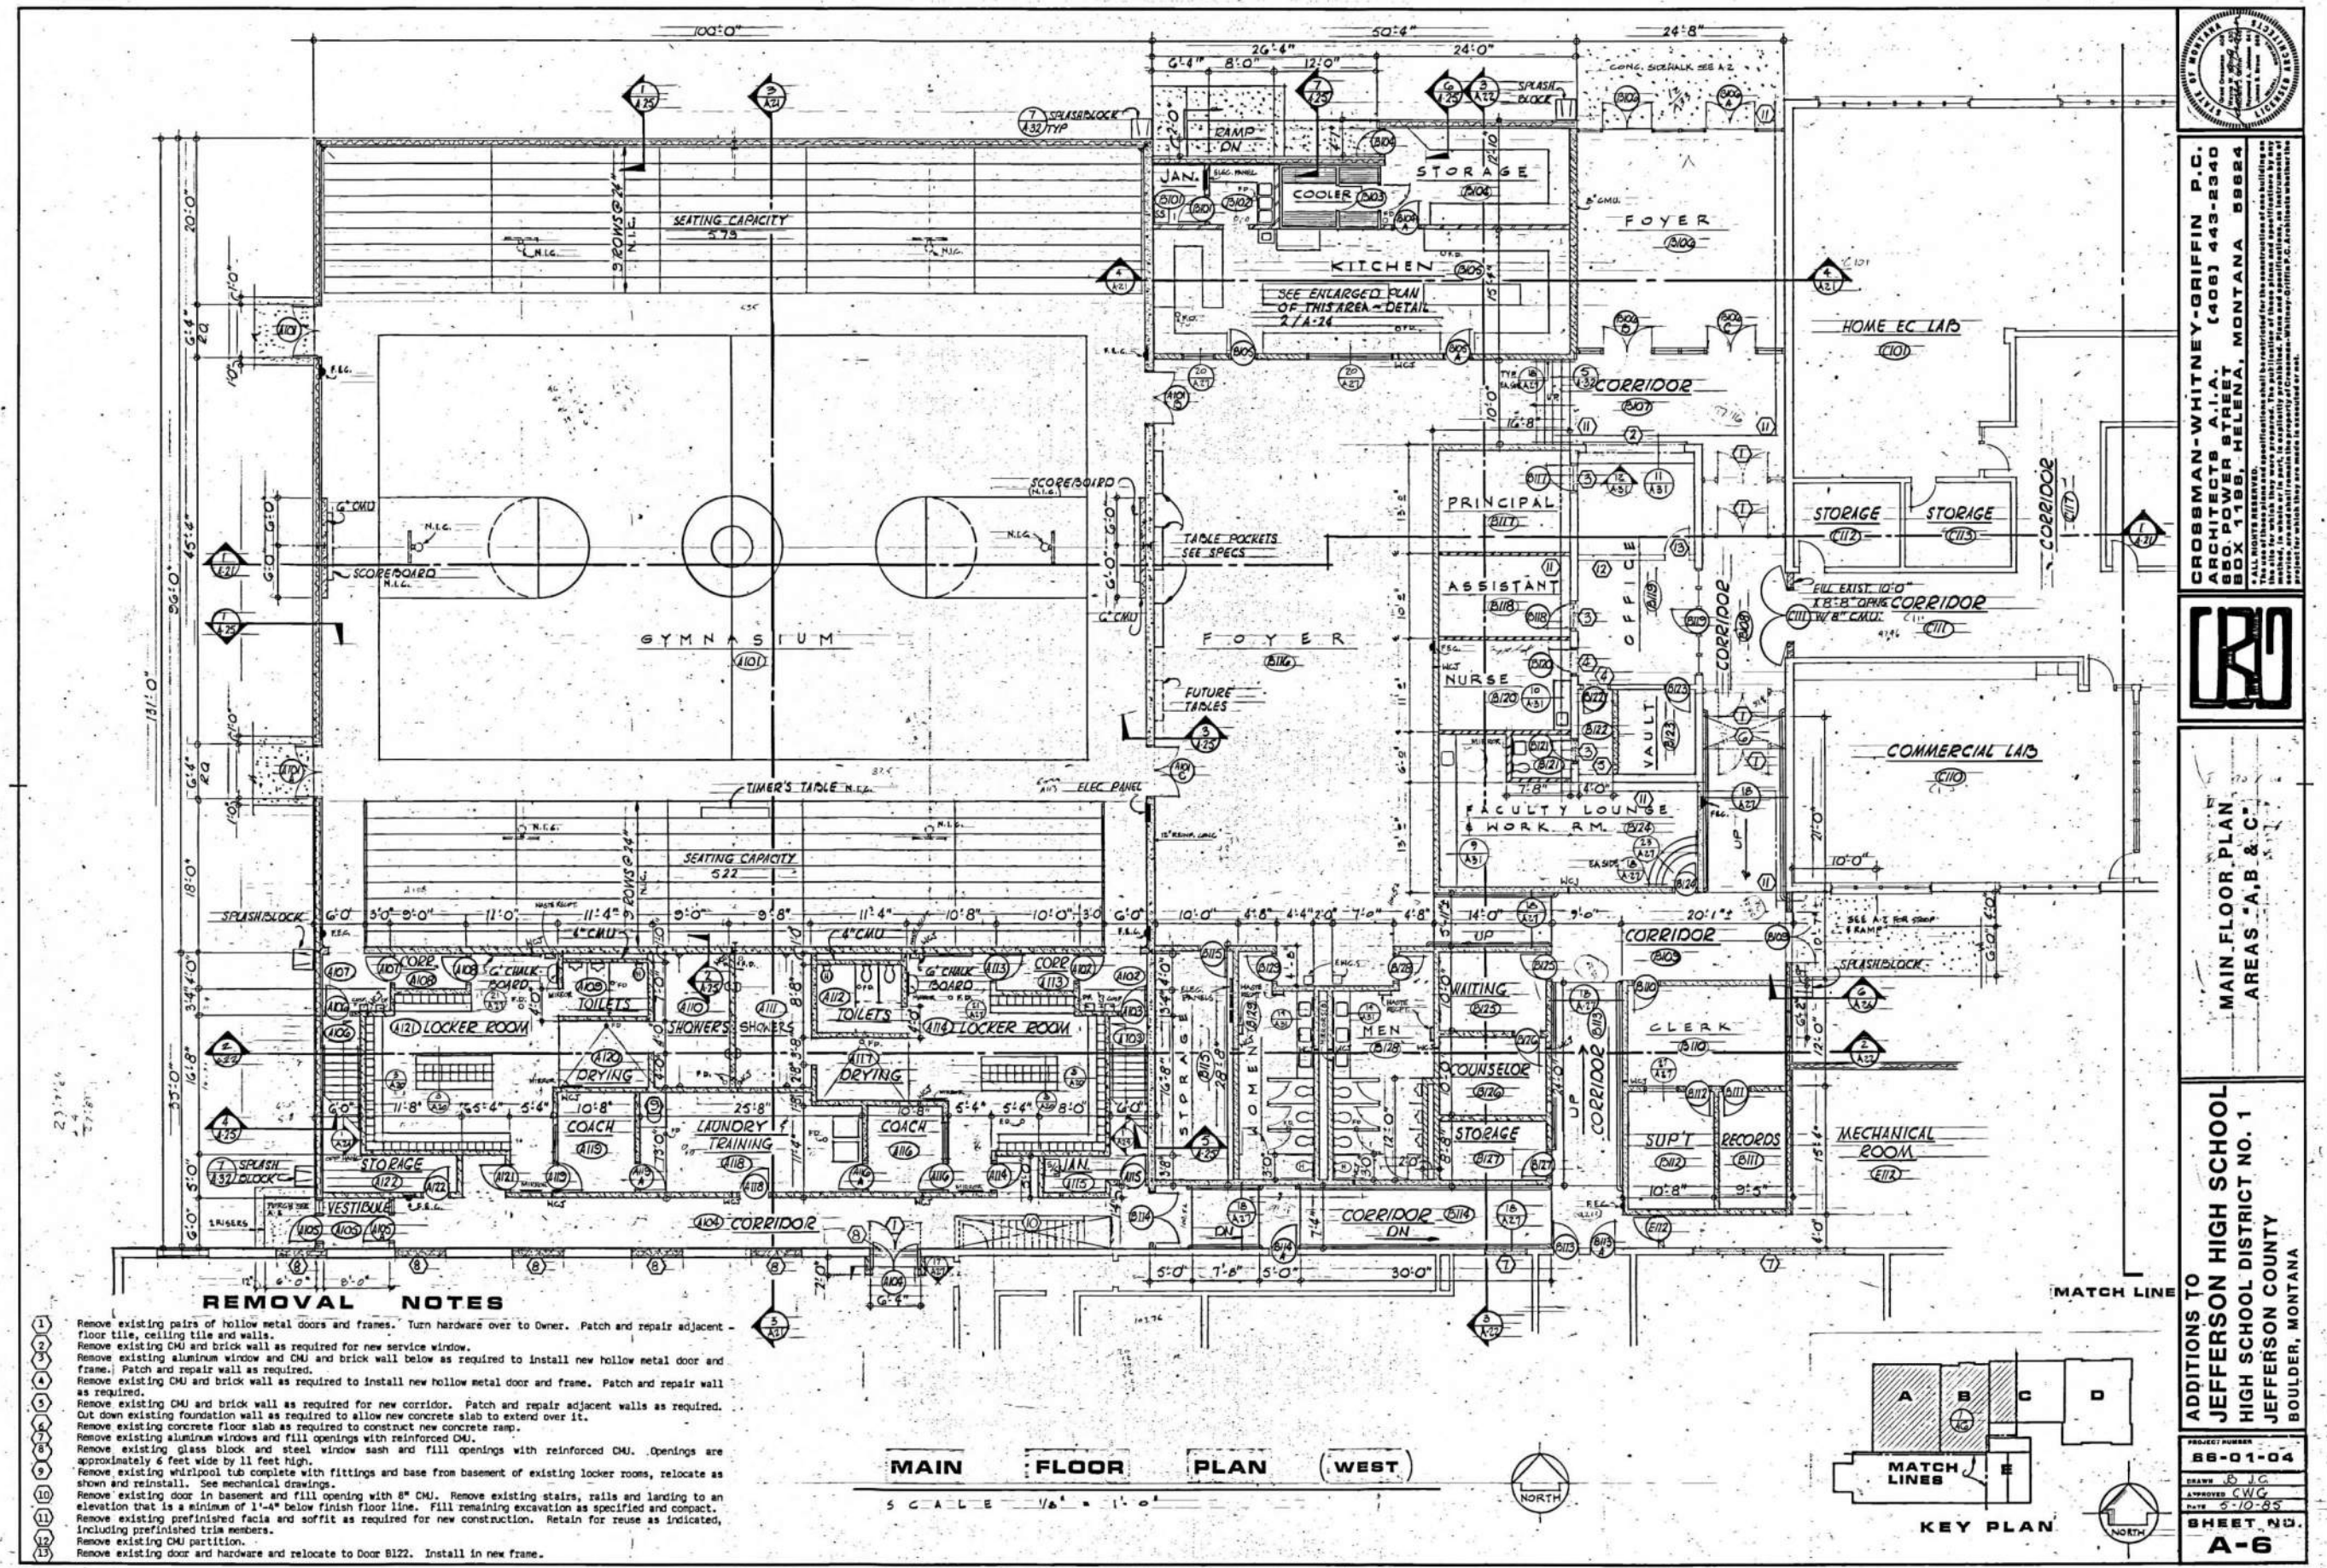
PROJECT NUMBER: **66-01-04**
 DRAWN BY: **J.S.B.**
 APPROVED: **C.M.C.**
 DATE: **5/10/85**
 SHEET NO.: **A-2**
