Jefferson High School Building Condition Report

312 S Main Street, Boulder, Montana 59632

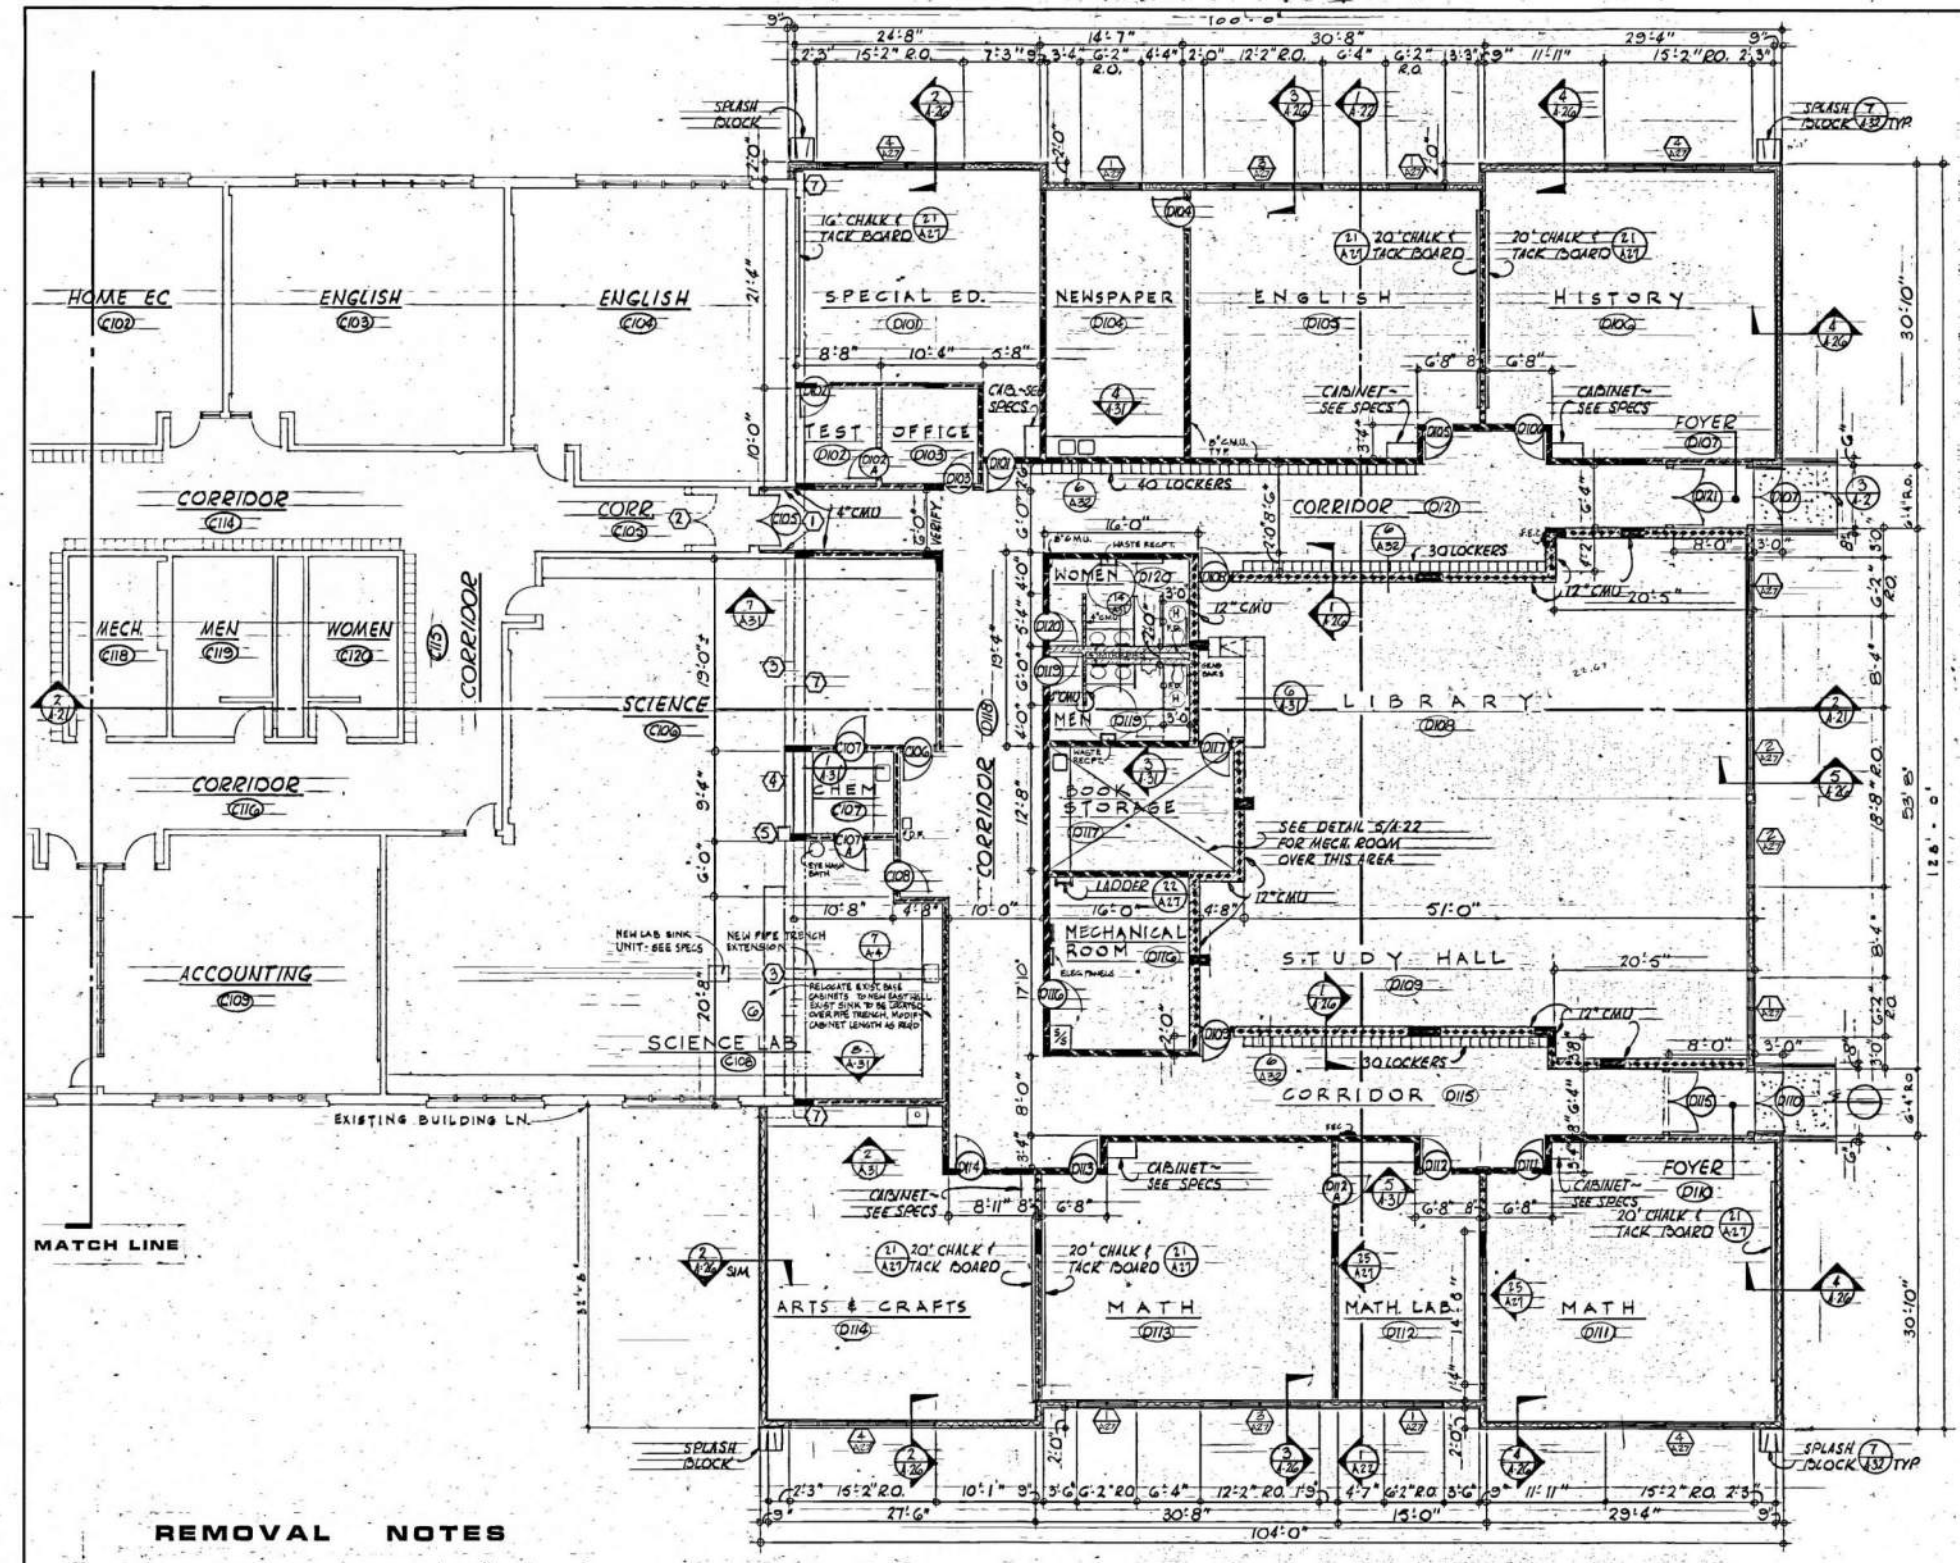
- ### REMOVAL NOTES
- 1 Remove existing brick, return to doors and replace with 4" CMU.
 - 2 Remove existing pair of hollow metal doors and frame. Patch and repair floor tile, ceiling tile, walls and paint.
 - 3 Remove existing CMU and brick wall. Patch and repair adjacent walls. Cut existing foundation wall down to allow new concrete slab to extend over it.
 - 4 Existing CMU and brick wall to remain in place. Patch and repair as required.
 - 5 Existing CMU pilaster to remain in place. Patch and repair as required.
 - 6 Remove existing base cabinets, relocate to new east wall of Room C108 - Science Lab, modify as required and reinstall.
 - 7 Remove existing prefinished soffit and fascia as required for new construction. Retain for reuse as indicated, including prefinished trim members.
